Access Compliance Report

Public Rights-of-Way

(Curb Ramps)

Intersection ID: 10470	Main Street: MILTON_RD	Cross Street: PERTH_CT	Location: NE
ADA ID: 07307ADAF606	Ramp Type: PerpDiag	Initial Pass/Fail: Fail	Overall Compliance: No
Severity Score: 31.25			
Codes/Mitigation Info/Possible Solution		Field Measurements/Component Compliance

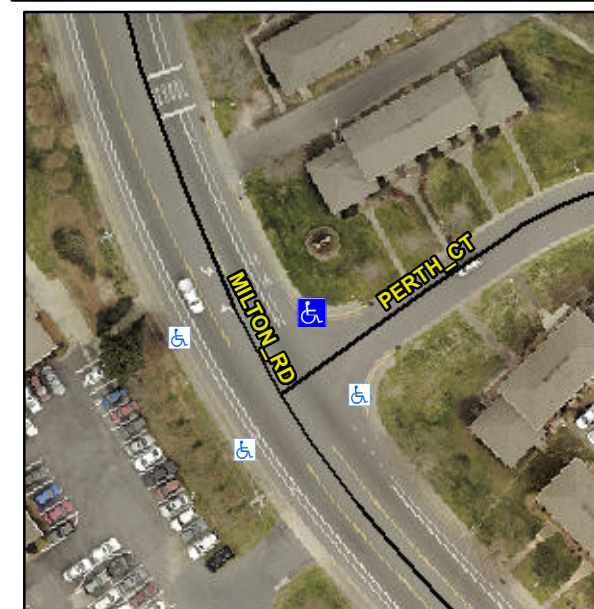
Not Found, R304.5.1, R304.2.2, R304.5.3

Compliance	Description	Data	Compliance	Description	Data
N/A	Ramp Length (in)	59.5	No	Ramp Slope (%)	10.2
No	Ramp Width (in)	35.0	No	Ramp XSlope (%)	2.4
N/A	Flare Type LT	N/A	N/A	Flare Type RT	N/A
N/A	Flare Slope LT (%)	N/A	N/A	Flare Slope RT (%)	N/A
N/A	Flare Traversable LT?	N/A	N/A	Flare Traversable RT?	N/A
N/A	Landing Length (in)	N/A	N/A	DWS Provided?	N/A
N/A	Landing Width (in)	N/A	N/A	DWS Contrast?	N/A
N/A	Landing Slope (%)	N/A	N/A	DWS Length (in)	N/A
N/A	Landing X Slope (%)	N/A	N/A	DWS Full Width?	N/A
N/A	Landing Curb? (Y/N)	N/A	N/A	DWS Offset (in)	N/A
N/A	Shared Landing?	N/A			
N/A	Gutter Ponding?	N/A	N/A	Gutter Slope (%)	N/A
N/A	Gutter Lip Ht (in)	N/A	N/A	Gutter X Slope (%)	N/A
N/A	Painted X Walk1?	No	N/A	Painted X Walk2?	No
	X Walk 1 Direction	To W		X Walk 2 Direction	To SE
N/A	X Walk 1 Width (in)	N/A	N/A	X Walk 2 Width (in)	N/A
	X Walk 1 Slope (%)	5.0		X Walk 2 Slope (%)	0.1
	X Walk 1 X Slope (%)	3.1		X Walk 2 X Slope (%)	1.6

N/A	Ramp inside XWalk1?	N/A	N/A	Ramp inside XWalk2?	N/A
	Road Slope (%)	2.6	N/A	Clear Space?	N/A
	Road X Slope (%)	1.7	N/A	Clear Space to XWalk (in)	N/A
N/A	Any Obstructions?	N/A	N/A	Storm Grate/Utility Hazard?	N/A
	Obstruction Type			Storm Grate/Utility Type	
		N/A			N/A
			Yes	Surface Condition? (G/P)	Good

Remove & Replace Curb Ramp With Two New Directional Ramps or Equivalent.
