## **Access Compliance Report Public Rights-of-Way** (Curb Ramps)

Intersection ID: 10030508 Main Street: LITTLE GEM LN **Cross Street: N/A** Location: SW ADA ID: 0737D302A9BB Ramp Type: PerpDiag Initial Pass/Fail: Fail **Overall Compliance: No Severity Score:** 35

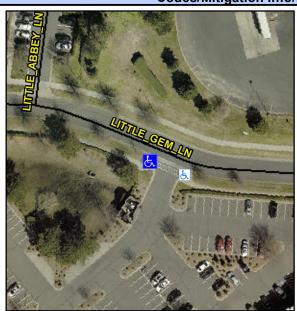
| Compliance Description Da | | Data | Compliance Description | | Data |
|---|---|---|---|---|---|
| No | Ramp Width (in) | 30.0 | Yes | Ramp XSlope (%) | 0.4 |

Possible Solutions: **Remove & Replace Curb Ramp With Two New Directional Ramps or** Equivalent. Surveyor Notes: N/A PROW/ADA: Not Found, R304.5.1
