Access Compliance Report Public Rights-of-Way (Curb Ramps)

Intersection ID: 45828 Main Street: CHRISTENBURY HILLS LN Cross Street: GRAYS RIDGE DR Location: SW **ADA ID: 074CD4E9D1C0** Ramp Type: PerpDiag Initial Pass/Fail: Fail **Overall Compliance: No Severity Score:** 55

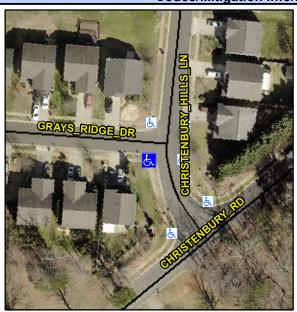
Not Found, R304.5.1, R304.2.2, R304.5.3

Compliance Description		Data	Compliance Description		Data
N/A	Ramp Length (in)	47.0	No	Ramp Slope (%)	19.5
No	Ramp Width (in)	34.5	No	Ramp XSlope (%)	5.1
N/A	Flare Type LT	N/A	N/A	Flare Type RT	N/A
N/A	Flare Slope LT (%)	N/A	N/A	Flare Slope RT (%)	N/A
N/A	Flare Traversable LT?	N/A	N/A	Flare Traversable RT?	N/A
N/A	Landing Length (in)	N/A	N/A	DWS Provided?	N/A
N/A	Landing Width (in)	N/A	N/A	DWS Contrast?	N/A
N/A	Landing Slope (%)	N/A	N/A	DWS Length (in)	N/A
N/A	Landing X Slope (%)	N/A	N/A	DWS Full Width?	N/A
N/A	Landing Curb? (Y/N)	N/A	N/A	DWS Offset (in)	N/A
N/A	Shared Landing?	N/A			
N/A	Gutter Ponding?	N/A	N/A	Gutter Slope (%)	N/A
N/A	Gutter Lip Ht (in)	N/A	N/A	Gutter X Slope (%)	N/A
N/A	Painted X Walk1?	No	N/A	Painted X Walk2?	No
	X Walk 1 Direction	To E		X Walk 2 Direction	To N
N/A	X Walk 1 Width (in)	N/A	N/A	X Walk 2 Width (in)	N/A
	X Walk 1 Slope (%)	2.1		X Walk 2 Slope (%)	1.8
	X Walk 1 X Slope (%)	3.1		X Walk 2 X Slope (%)	1.8

N/A	Ramp inside XWalk1?	N/A	N/A	Ramp inside XWalk2?	N/A
	Road Slope (%)	2.5	N/A	Clear Space?	N/A
	Road X Slope (%)	0.9	N/A	Clear Space to XWalk (in)	N/A
N/A	Any Obstructions?	N/A	N/A	Storm Grate/Utility Hazard?	N/A
	Obstruction Type		l	Storm Grate/Utility Type	
		N/A			N/A
			Yes	Surface Condition? (G/P)	Good

Possible Solutions: Remove & Replace Curb Ramp With Two New Directional Ramps or Equivalent.

3200.00
