# Access Compliance Report

## Public Rights-of-Way

### (Curb Ramps)

| Intersection ID: 18266 | Main Street: BATHURST_DR | Cross Street: LOUVAINE_DR | Location: SW |

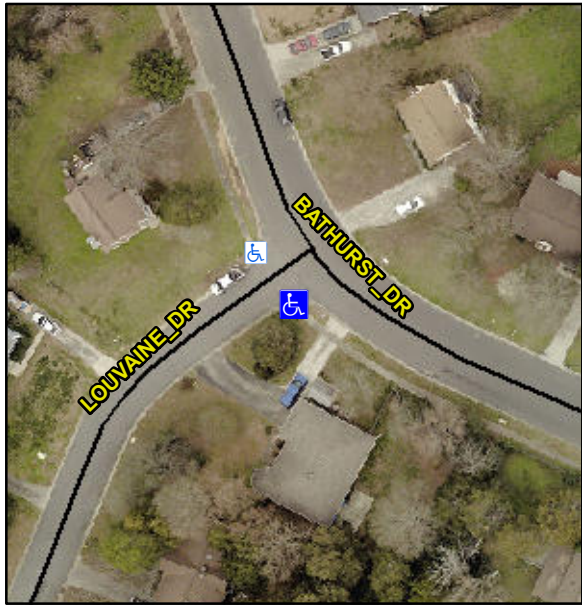
| ADA ID: 074F5CDBF87E | Ramp Type: Perp | Initial Pass/Fail: Fail | Overall Compliance: No |
| Severity Score: 26.25 | | | |

Not Found, R304.2.2, R304.5.3

| Compliance | Description | Data | Compliance | Description | Data |
|---|---|---|---|---|---|
| N/A | Ramp Length (in) | 58.0 | No | Ramp Slope (%) | 13.9 |
| Yes | Ramp Width (in) | 50.0 | No | Ramp XSlope (%) | 4.8 |

Remove & Replace Entire Ramp.

1850.00
