Access Compliance Report

Public Rights-of-Way

(Curb Ramps)

| Intersection ID: 10012432 | Main Street: FAIRES_FARM_RD | Cross Street: N/A | Location: E |

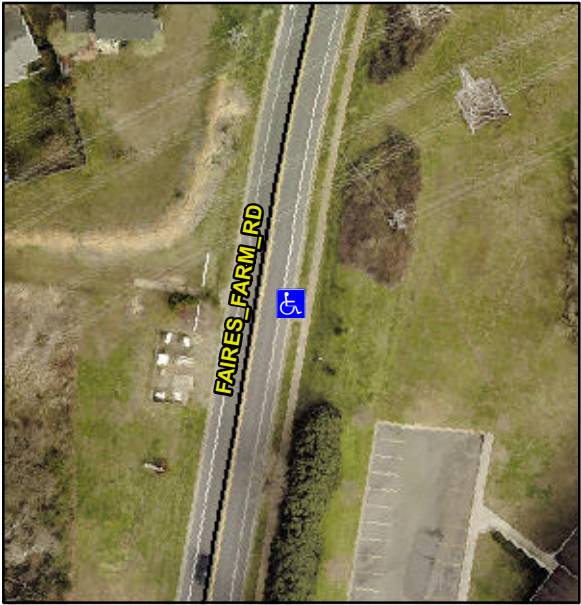
| ADA ID: 075747CCB279 | Ramp Type: Perp | Initial Pass/Fail: Fail | Overall Compliance: No |

| Codes/Mitigation Info/Possible Solution | | | Field Measurements/Component Compliance | | |
|---|---|---|---|---|---|
| | | | No | Ramp Width (in) | 45.0 |
| <p>Surveyor Notes:</p> <p>N/A</p> <p>PROW/ADA:</p> <p>Not Found, R304.5.1, R304.2.2</p> | | | N/A | Flare Type RT | N/A |

| Codes/Mitigation Info/Possible Solution | | | Field Measurements/Component Compliance | | |
|---|---|---|---|---|---|
| | Remove & Replace Entire Ramp. | | N/A | Ramp Length (in) | 60.0 |
| Total Cost: | | \$ 1850.00 | | | |
