Access Compliance Report

Public Rights-of-Way

(Curb Ramps)

Intersection ID: 3565	Main Street: ROTHERHAM_LN	Cross Street: TREYBURN_DR	Location: NW
ADA ID: 0759DBEB6900	Ramp Type: Perp	Initial Pass/Fail: Fail	Overall Compliance: No
		Severity Score: 12.5

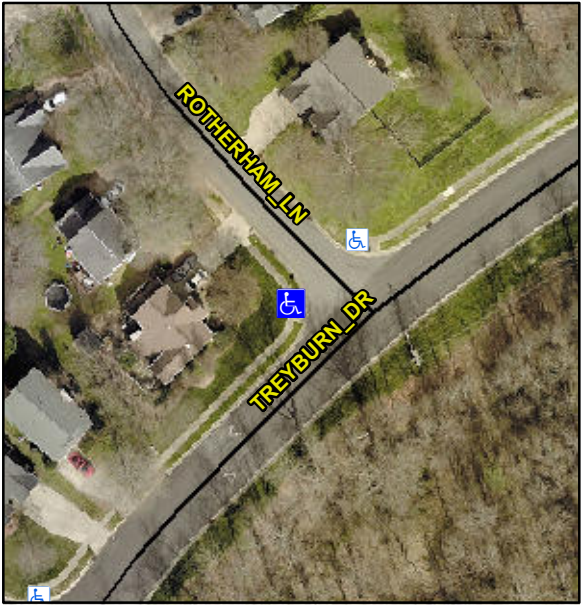
Possible Solutions:		Compliance	Description	Data
	Remove & Replace Entire Ramp.		No	Ramp Length (in)	54.0
			Yes	Ramp Width (in)	48.0
			N/A	Flare Type LT	N/A
			N/A	Flare Slope LT (%)	N/A
			N/A	Flare Traversable LT?	N/A
			N/A	Landing Length (in)	N/A
			N/A	Landing Width (in)	N/A
			N/A	Landing Slope (%)	N/A
			N/A	Landing X Slope (%)	N/A
<p>Surveyor Notes:</p> <p>N/A</p> <p>PROW/ADA:</p> <p>Not Found, R304.2.2</p>			N/A	Flare Type RT	N/A
			N/A	Flare Slope RT (%)	N/A
			N/A	Flare Traversable RT?	N/A
			N/A	DWS Provided?	N/A
			N/A	DWS Contrast?	N/A
			N/A	DWS Length (in)	N/A
			N/A	DWS Full Width?	N/A
			N/A	DWS Offset (in)	N/A
			N/A	Shared Landing?	N/A
			N/A	Gutter Ponding?	N/A
			N/A	Gutter Lip Ht (in)	N/A
			N/A	Painted X Walk1?	No
				X Walk 1 Direction	To NE
			N/A	X Walk 1 Width (in)	N/A
				X Walk 1 Slope (%)	1.3
				X Walk 1 X Slope (%)	0.6

N/A	Ramp inside XWalk1?	N/A
			N/A	Road Slope (%)	N/A
			N/A	Road X Slope (%)	N/A
			N/A	Any Obstructions?	N/A
Total Cost:		\$ 1850.00		Obstruction Type	
			N/A	Storm Grate/Utility Hazard?	N/A
				Storm Grate/Utility Type	
			N/A		N/A
			Yes	Surface Condition? (G/P)	Good
