Access Compliance Report

Public Rights-of-Way

Intersection ID: 23312	Main Street: BALTUSROL_LN	Cross Street: GLENEAGLES_RD	Location: SE
ADA ID: 076279B1A6F3	Ramp Type: PerpDiag	Initial Pass/Fail: Fail	Overall Compliance: No
Severity Score: 21.25			
Codes/Mitigation Info/Possible Solution		Field Measurements/Component Compliance

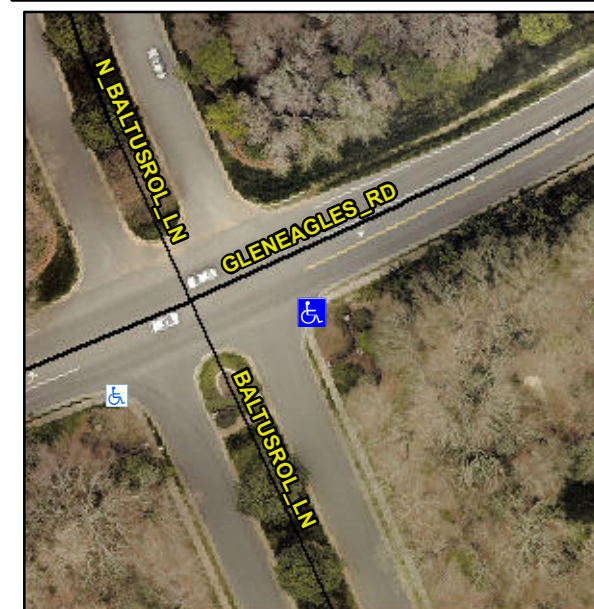
Not Found, R304.5.1, R304.2.2

Compliance	Description	Data	Compliance	Description	Data
N/A	Ramp Length (in)	48.0	No	Ramp Slope (%)	8.7
No	Ramp Width (in)	47.0	Yes	Ramp XSlope (%)	0.3
N/A	Flare Type LT	N/A	N/A	Flare Type RT	N/A
N/A	Flare Slope LT (%)	N/A	N/A	Flare Slope RT (%)	N/A
N/A	Flare Traversable LT?	N/A	N/A	Flare Traversable RT?	N/A
N/A	Landing Length (in)	N/A	N/A	DWS Provided?	N/A
N/A	Landing Width (in)	N/A	N/A	DWS Contrast?	N/A
N/A	Landing Slope (%)	N/A	N/A	DWS Length (in)	N/A
N/A	Landing X Slope (%)	N/A	N/A	DWS Full Width?	N/A
N/A	Landing Curb? (Y/N)	N/A	N/A	DWS Offset (in)	N/A
N/A	Shared Landing?	N/A			
N/A	Gutter Ponding?	N/A	N/A	Gutter Slope (%)	N/A
N/A	Gutter Lip Ht (in)	N/A	N/A	Gutter X Slope (%)	N/A
N/A	Painted X Walk1?	No	N/A	Painted X Walk2?	No
	X Walk 1 Direction	To N		X Walk 2 Direction	To W
N/A	X Walk 1 Width (in)	N/A	N/A	X Walk 2 Width (in)	N/A
	X Walk 1 Slope (%)	6.9		X Walk 2 Slope (%)	1.1
	X Walk 1 X Slope (%)	3.5		X Walk 2 X Slope (%)	3.2

N/A	Ramp inside XWalk1?	N/A	N/A	Ramp inside XWalk2?	N/A
	Road Slope (%)	0.1	N/A	Clear Space?	N/A
	Road X Slope (%)	10.4	N/A	Clear Space to XWalk (in)	N/A
N/A	Any Obstructions?	N/A	N/A	Storm Grate/Utility Hazard?	N/A
	Obstruction Type			Storm Grate/Utility Type	
		N/A			N/A
		Yes		Surface Condition? (G/P)	Good

Remove & Replace Curb Ramp With Two New Directional Ramps or Equivalent.
