# Access Compliance Report

## Public Rights-of-Way

### (Curb Ramps)

Intersection ID: 20620	Main Street: OLD_REID_RD	Cross Street: WADEBRIDGE_CV	Location: E
ADA ID: 077ABDDC2F78	Ramp Type: PerpDiag	Initial Pass/Fail: Fail	Overall Compliance: No
Severity Score: 12.5			
Codes/Mitigation Info/Possible Solution		Field Measurements/Component Compliance

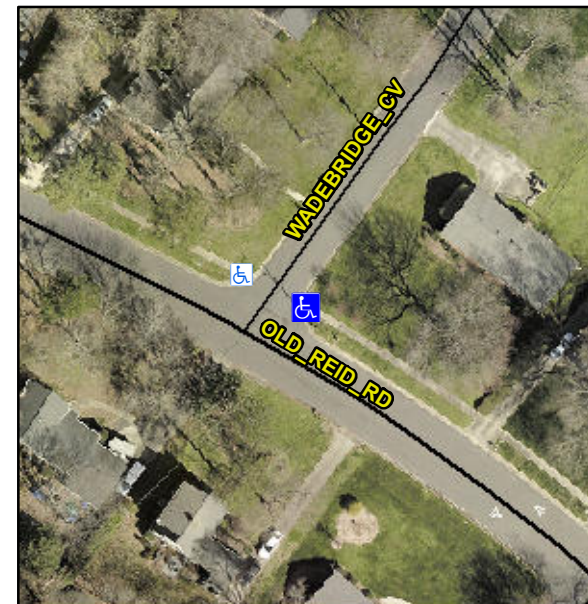
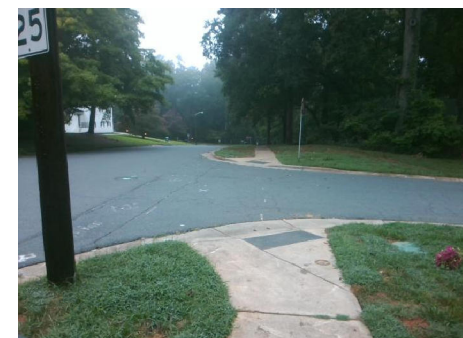
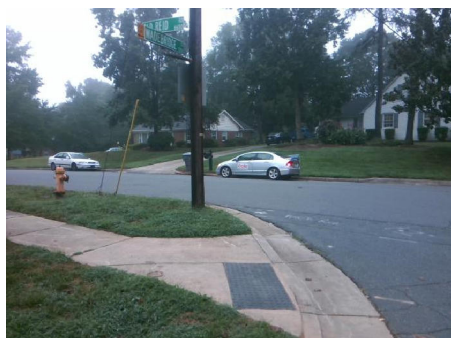
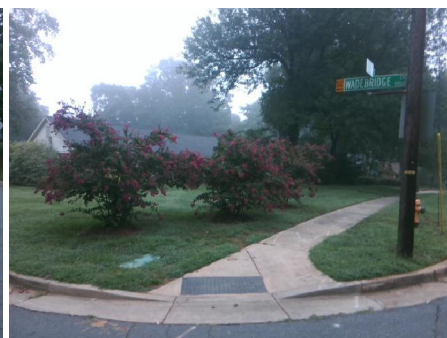
**Not Found, R304.2.2**

Compliance	Description	Data	Compliance	Description	Data
N/A	Ramp Length (in)	48.0	No	Ramp Slope (%)	9.2
Yes	Ramp Width (in)	48.0	Yes	Ramp XSlope (%)	1.7
N/A	Flare Type LT	N/A	N/A	Flare Type RT	N/A
N/A	Flare Slope LT (%)	N/A	N/A	Flare Slope RT (%)	N/A
N/A	Flare Traversable LT?	N/A	N/A	Flare Traversable RT?	N/A
N/A	Landing Length (in)	N/A	N/A	DWS Provided?	N/A
N/A	Landing Width (in)	N/A	N/A	DWS Contrast?	N/A
N/A	Landing Slope (%)	N/A	N/A	DWS Length (in)	N/A
N/A	Landing X Slope (%)	N/A	N/A	DWS Full Width?	N/A
N/A	Landing Curb? (Y/N)	N/A	N/A	DWS Offset (in)	N/A
N/A	Shared Landing?	N/A			
N/A	Gutter Ponding?	N/A	N/A	Gutter Slope (%)	N/A
N/A	Gutter Lip Ht (in)	N/A	N/A	Gutter X Slope (%)	N/A
N/A	Painted X Walk1?	No	N/A	Painted X Walk2?	No
	X Walk 1 Direction	To NW		X Walk 2 Direction	To SW
N/A	X Walk 1 Width (in)	N/A	N/A	X Walk 2 Width (in)	N/A
	X Walk 1 Slope (%)	0.4		X Walk 2 Slope (%)	1.2
	X Walk 1 X Slope (%)	2.5		X Walk 2 X Slope (%)	1.1

N/A	Ramp inside XWalk1?	N/A	N/A	Ramp inside XWalk2?	N/A
	Road Slope (%)	2.8	N/A	Clear Space?	N/A
	Road X Slope (%)	1.1	N/A	Clear Space to XWalk (in)	N/A
N/A	Any Obstructions?	N/A	N/A	Storm Grate/Utility Hazard?	N/A
	Obstruction Type			Storm Grate/Utility Type	
		N/A			N/A
		Yes		Surface Condition? (G/P)	Good

**Remove & Replace Curb Ramp With Two New Directional Ramps or Equivalent.**
