# Access Compliance Report

## Public Rights-of-Way

### (Curb Ramps)

Intersection ID: 52918	Main Street: HOOVER_CREEK_BV	Cross Street: STEELE_CREEK_RD	Location: NW
ADA ID: 078B287A30F5	Ramp Type: Perp	Initial Pass/Fail: Fail	Overall Compliance: No
Severity Score: 10			
Codes/Mitigation Info/Possible Solution		Field Measurements/Component Compliance

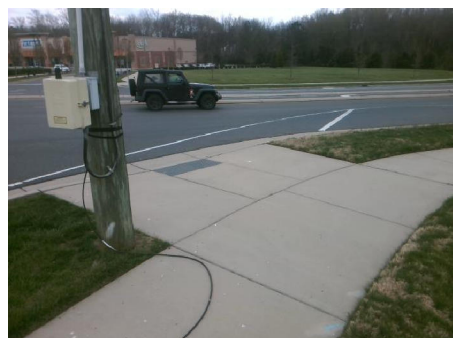
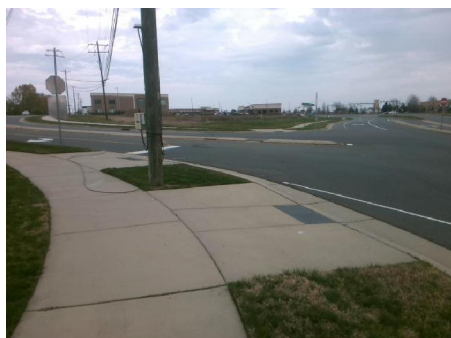
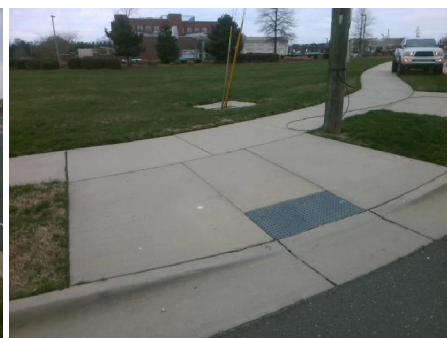
**Not Found, R304.5.1, R304.5.3**

Compliance	Description	Data	Compliance	Description	Data
N/A	Ramp Length (in)	102.0	Yes	Ramp Slope (%)	7.2
No	Ramp Width (in)	46.0	No	Ramp XSlope (%)	4.0
N/A	Flare Type LT	N/A	N/A	Flare Type RT	N/A
N/A	Flare Slope LT (%)	N/A	N/A	Flare Slope RT (%)	N/A
N/A	Flare Traversable LT?	N/A	N/A	Flare Traversable RT?	N/A
N/A	Landing Length (in)	N/A	N/A	DWS Provided?	N/A
N/A	Landing Width (in)	N/A	N/A	DWS Contrast?	N/A
N/A	Landing Slope (%)	N/A	N/A	DWS Length (in)	N/A
N/A	Landing X Slope (%)	N/A	N/A	DWS Full Width?	N/A
N/A	Landing Curb? (Y/N)	N/A	N/A	DWS Offset (in)	N/A
N/A	Shared Landing?	N/A			
N/A	Gutter Ponding?	N/A	N/A	Gutter Slope (%)	N/A
N/A	Gutter Lip Ht (in)	N/A	N/A	Gutter X Slope (%)	N/A
N/A	Painted X Walk1?	No	N/A	Painted X Walk2?	N/A
	X Walk 1 Direction	To SE		X Walk 2 Direction	N/A
N/A	X Walk 1 Width (in)	N/A	N/A	X Walk 2 Width (in)	N/A
	X Walk 1 Slope (%)	4.1		X Walk 2 Slope (%)	N/A
	X Walk 1 X Slope (%)	1.6		X Walk 2 X Slope (%)	N/A

N/A	Ramp inside XWalk1?	N/A	N/A	Ramp inside XWalk2?	N/A
	Road Slope (%)	N/A	N/A	Clear Space?	N/A
	Road X Slope (%)	N/A	N/A	Clear Space to XWalk (in)	N/A
N/A	Any Obstructions?	N/A	N/A	Storm Grate/Utility Hazard?	N/A
	Obstruction Type			Storm Grate/Utility Type	
		N/A			N/A
			Yes	Surface Condition? (G/P)	Good

**Remove & Replace Entire Ramp.**

Total Cost: \$ 1850.00
