# Access Compliance Report

## Public Rights-of-Way

### (Curb Ramps)

Intersection ID: 53750	Main Street: SPRINGWOOD_ESTATE_DR	Cross Street: SAGAMORE_HILL_DR	Location: NW
ADA ID: 07B6EFD37CE0	Ramp Type: BlendTrans1	Initial Pass/Fail: Fail	Overall Compliance: No
Severity Score: 21.25			
Codes/Mitigation Info/Possible Solution		Field Measurements/Component Compliance

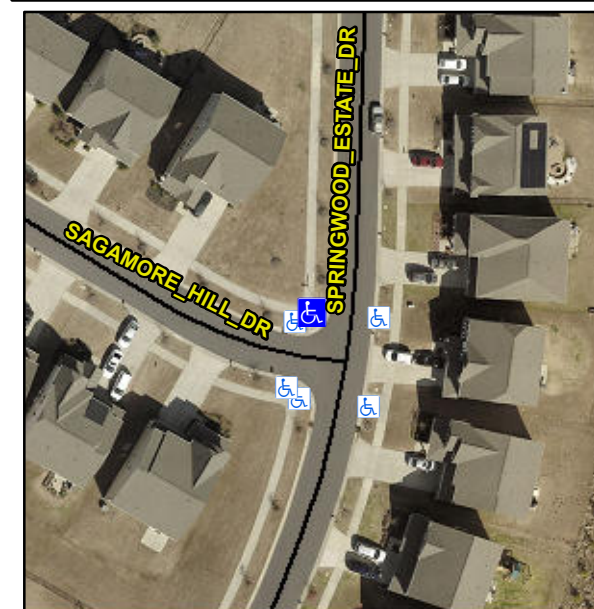
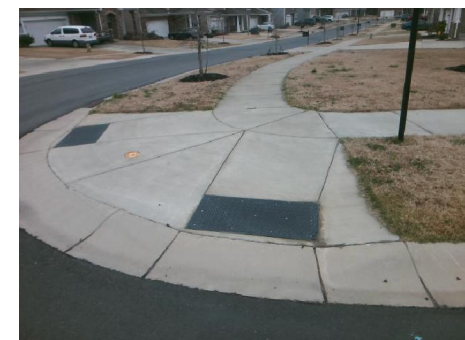
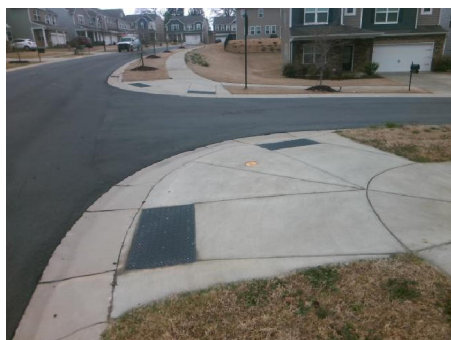
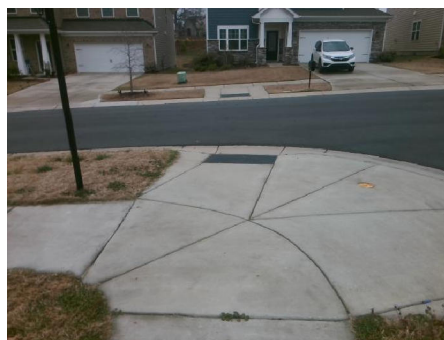
**Not Found, R304.5.1, R304.5.3**

Compliance	Description	Data	Compliance	Description	Data
N/A	Ramp Length (in)	101.0	Yes	BlendTrans Slope (%)	2.8
No	Ramp Width (in)	47.0	No	BlendTrans XSlope (%)	5.9
N/A	Flare Type LT	N/A	N/A	Flare Type RT	N/A
N/A	Flare Slope LT (%)	N/A	N/A	Flare Slope RT (%)	N/A
N/A	Flare Traversable LT?	N/A	N/A	Flare Traversable RT?	N/A
N/A	Landing Length (in)	N/A	N/A	DWS Provided?	N/A
N/A	Landing Width (in)	N/A	N/A	DWS Contrast?	N/A
N/A	Landing Slope (%)	N/A	N/A	DWS Length (in)	N/A
N/A	Landing X Slope (%)	N/A	N/A	DWS Full Width?	N/A
N/A	Landing Curb? (Y/N)	N/A	N/A	DWS Offset (in)	N/A
N/A	Shared Landing?	N/A			
N/A	Gutter Ponding?	N/A	N/A	Gutter Slope (%)	N/A
N/A	Gutter Lip Ht (in)	N/A	N/A	Gutter X Slope (%)	N/A
N/A	Painted X Walk1?	No	N/A	Painted X Walk2?	N/A
	X Walk 1 Direction	To E		X Walk 2 Direction	N/A
	X Walk 1 Width (in)	N/A		X Walk 2 Width (in)	N/A
	X Walk 1 Slope (%)	2.3		X Walk 2 Slope (%)	N/A
	X Walk 1 X Slope (%)	4.0		X Walk 2 X Slope (%)	N/A

N/A	Ramp inside XWalk1?	N/A	N/A	Ramp inside XWalk2?	N/A
	Road Slope (%)	4.0		Clear Space?	N/A
	Road X Slope (%)	2.3	N/A	Clear Space to XWalk (in)	N/A
N/A	Any Obstructions?	N/A	N/A	Storm Grate/Utility Hazard?	N/A
	Obstruction Type			Storm Grate/Utility Type	
		N/A			N/A
			Yes	Surface Condition? (G/P)	Good
			No	Curb Slope (%)	5.2

**Remove & Replace Curb Ramp With Two New Directional Ramps or Equivalent.**
