# Access Compliance Report

## Public Rights-of-Way

### (Curb Ramps)

Intersection ID: 18381	Main Street: BATHURST_DR	Cross Street: WYALONG_DR	Location:	NE
ADA ID: 07B779246AFE	Ramp Type: Perp	Initial Pass/Fail: Pass	Overall Compliance: No	Severity Score: 5
Codes/Mitigation Info/Possible Solution		Field Measurements/Component Compliance

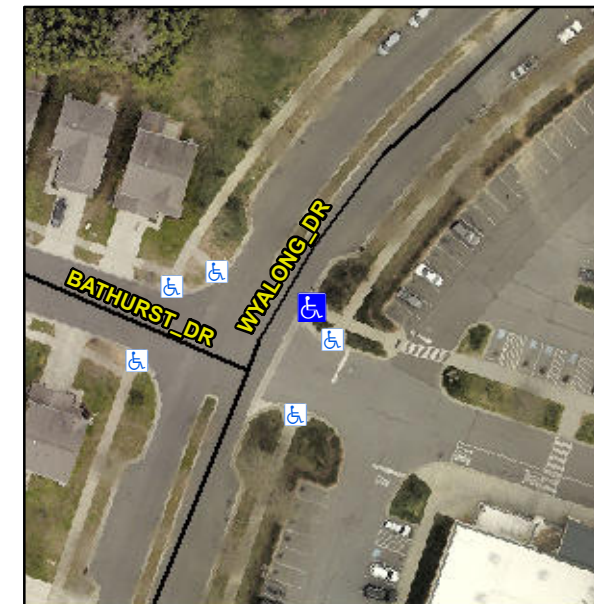
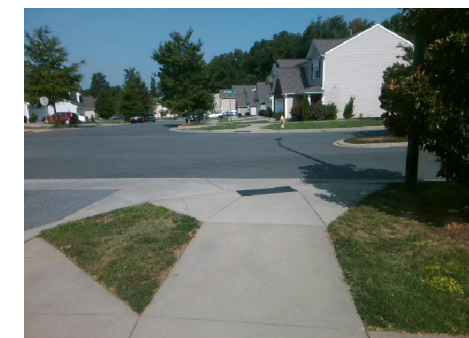
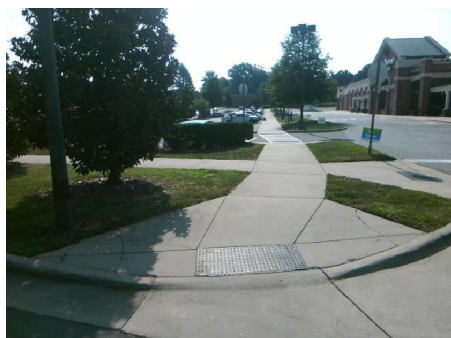
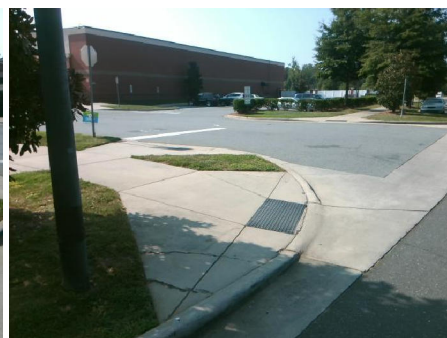
**Not Found, R305.2, R304.5.4**

Compliance	Description	Data	Compliance	Description	Data
N/A	Ramp Length (in)	112.0	Yes	Ramp Slope (%)	6.4
Yes	Ramp Width (in)	48.0	Yes	Ramp XSlope (%)	0.8
N/A	Flare Type LT	Sloped	N/A	Flare Type RT	N/A
N/A	Flare Slope LT (%)	0.7	N/A	Flare Slope RT (%)	3.5
N/A	Flare Traversable LT?	No	N/A	Flare Traversable RT?	No
Yes	Landing Length (in)	91.0	Yes	DWS Provided?	Yes
Yes	Landing Width (in)	48.0	Yes	DWS Contrast?	Yes
Yes	Landing Slope (%)	0.7	Yes	DWS Length (in)	24.5
Yes	Landing X Slope (%)	1.6	Yes	DWS Full Width?	Yes
N/A	Landing Curb? (Y/N)	No	No	DWS Offset (in)	2.5
N/A	Shared Landing?	No			
Yes	Gutter Ponding?	No	No	Gutter Slope (%)	6.8
Yes	Gutter Lip Ht (in)	0.0	Yes	Gutter X Slope (%)	0.4
N/A	Painted X Walk1?	No	N/A	Painted X Walk2?	N/A
	X Walk 1 Direction	To NW		X Walk 2 Direction	N/A
N/A	X Walk 1 Width (in)	N/A	N/A	X Walk 2 Width (in)	N/A
	X Walk 1 Slope (%)	1.3		X Walk 2 Slope (%)	N/A
	X Walk 1 X Slope (%)	1.1		X Walk 2 X Slope (%)	N/A

N/A	Ramp inside XWalk1?	N/A	N/A	Ramp inside XWalk2?	N/A
	Road Slope (%)	N/A	N/A	Clear Space?	Yes
	Road X Slope (%)	N/A	N/A	Clear Space to XWalk (in)	N/A
Yes	Any Obstructions?	No	Yes	Storm Grate/Utility Hazard?	No
	Obstruction Type			Storm Grate/Utility Type	
		N/A			N/A
			Yes	Surface Condition? (G/P)	Good

Possible Solutions:

**Remove & Replace Entire Ramp.  
Remove & Replace Gutter.**
