## Access Compliance Report Public Rights-of-Way (Curb Ramps)

Intersection ID: 27363Main Street:REA\_RDCross Street:BALLANTYNE\_COMMONS\_PYLocation:SWADA ID: 07BA519D40DBRamp Type:ParaDiagInitial Pass/Fail:FailOverall Compliance:NoSeverity Score:37.5

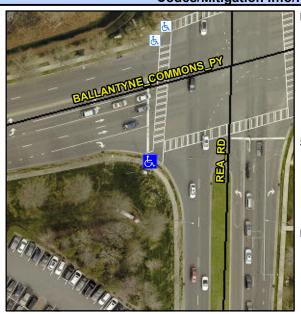
Compliance Description Data			Compliance Description		Data
N/A	Ramp Length LT (in)	66.0	N/A	Ramp Length RT (in)	61.0
Yes	Ramp Width LT (in)	108.0	Yes	Ramp Width RT (in)	110.0
No	Ramp Slope LT (%)	8.8	No	Ramp Slope RT (%)	9.2
No	Ramp XSlope LT (%)	7.6	No	Ramp XSlope RT (%)	8.4
N/A	Landing Length (in)	N/A	N/A	DWS Provided?	N/A
N/A	Landing Width (in)	N/A	N/A	DWS Contrast?	N/A
N/A	Landing Slope (%)	N/A	N/A	DWS Length (in)	N/A
N/A	Landing X Slope (%)	N/A	N/A	DWS Full Width?	N/A
N/A	Landing Curb? (Y/N)	N/A	N/A	DWS Offset (in)	N/A
N/A	Shared Landing?	N/A			
N/A	Gutter Ponding?	N/A	N/A	Gutter Slope (%)	N/A
N/A	Gutter Lip Ht (in)	N/A	N/A	Gutter X Slope (%)	N/A
N/A	Painted X Walk1?	Yes	N/A	Painted X Walk2?	Yes
	X Walk 1 Direction	To NE		X Walk 2 Direction	To N
N/A	X Walk 1 Width (in)	124.0	N/A	X Walk 2 Width (in)	120.0
	X Walk 1 Slope (%)	0.8		X Walk 2 Slope (%)	0.1
	X Walk 1 X Slope (%)	1.0		X Walk 2 X Slope (%)	1.1

N/A	Ramp inside XWalk1?	Yes	N/A	Ramp inside XWalk2?	Yes
	Road Slope (%)	0.5	N/A	Clear Space?	N/A
	Road X Slope (%)	0.3	N/A	Clear Space to XWalk (in)	N/A
N/A	Any Obstructions?	N/A	N/A	Storm Grate/Utility Hazard?	N/A
	Obstruction Type			Storm Grate/Utility Type	
		N/A			N/A
			Yes	Surface Condition? (G/P)	Good
			N/A	Curb Slope (%)	12.8

Remove & Replace Curb Ramp With Two New Directional Ramps or Equivalent.
