Access Compliance Report

Public Rights-of-Way

(Curb Ramps)

Intersection ID: 45514	Main Street: MEADOW_BOTTOM_RD	Cross Street: COTTON_PRESS_RD	Location: S
ADA ID: 07BBED4A57D2	Ramp Type: PerpDiag	Initial Pass/Fail: Fail	Overall Compliance: No
Severity Score: 31.25			
Codes/Mitigation Info/Possible Solution		Field Measurements/Component Compliance

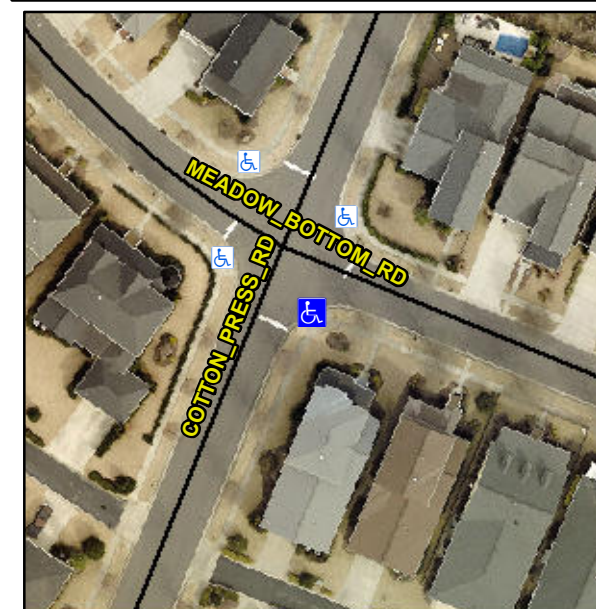
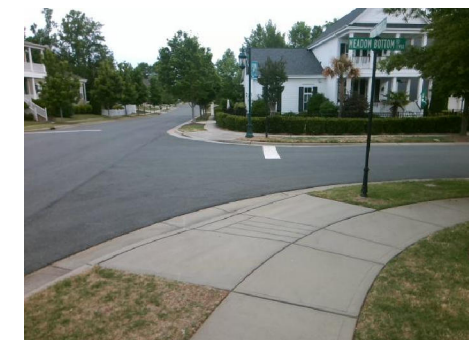
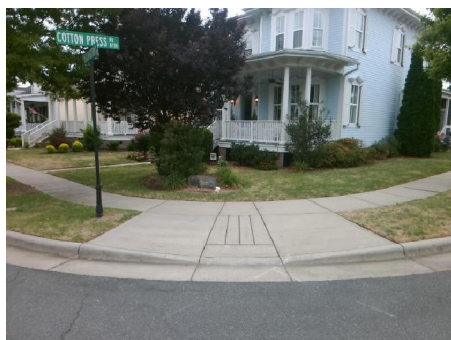
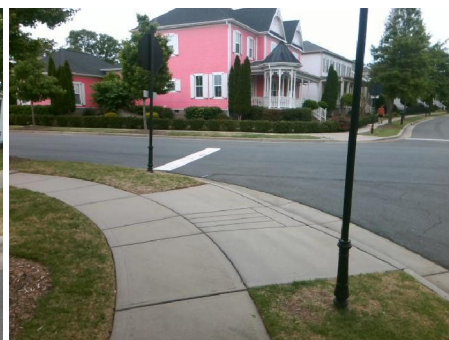
Not Found, R304.5.1, R304.2.2, R304.5.3

Compliance	Description	Data	Compliance	Description	Data
N/A	Ramp Length (in)	72.0	No	Ramp Slope (%)	11.3
No	Ramp Width (in)	33.0	No	Ramp XSlope (%)	2.6
N/A	Flare Type LT	N/A	N/A	Flare Type RT	N/A
N/A	Flare Slope LT (%)	N/A	N/A	Flare Slope RT (%)	N/A
N/A	Flare Traversable LT?	N/A	N/A	Flare Traversable RT?	N/A
N/A	Landing Length (in)	N/A	N/A	DWS Provided?	N/A
N/A	Landing Width (in)	N/A	N/A	DWS Contrast?	N/A
N/A	Landing Slope (%)	N/A	N/A	DWS Length (in)	N/A
N/A	Landing X Slope (%)	N/A	N/A	DWS Full Width?	N/A
N/A	Landing Curb? (Y/N)	N/A	N/A	DWS Offset (in)	N/A
N/A	Shared Landing?	N/A			
N/A	Gutter Ponding?	N/A	N/A	Gutter Slope (%)	N/A
N/A	Gutter Lip Ht (in)	N/A	N/A	Gutter X Slope (%)	N/A
N/A	Painted X Walk1?	No	N/A	Painted X Walk2?	No
	X Walk 1 Direction	To NE		X Walk 2 Direction	To NW
N/A	X Walk 1 Width (in)	N/A	N/A	X Walk 2 Width (in)	N/A
	X Walk 1 Slope (%)	0.2		X Walk 2 Slope (%)	3.3
	X Walk 1 X Slope (%)	0.9		X Walk 2 X Slope (%)	0.4

N/A	Ramp inside XWalk1?	N/A	N/A	Ramp inside XWalk2?	N/A
	Road Slope (%)	2.1	N/A	Clear Space?	N/A
	Road X Slope (%)	2.4	N/A	Clear Space to XWalk (in)	N/A
N/A	Any Obstructions?	N/A	N/A	Storm Grate/Utility Hazard?	N/A
	Obstruction Type			Storm Grate/Utility Type	
		N/A			N/A
			Yes	Surface Condition? (G/P)	Good

Remove & Replace Curb Ramp With Two New Directional Ramps or Equivalent.
