Access Compliance Report Public Rights-of-Way (Curb Ramps)

Main Street: N TRYON ST Location: Intersection ID: 10555 Cross Street: W 23RD ST Initial Pass/Fail: Fail **Overall Compliance: No** ADA ID: 07C0FFE831C3 Ramp Type: BlendTrans1 Severity Score: 21.25

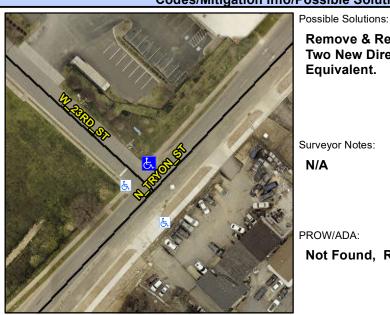
Not Found, R304.5.1, R304.5.3

W 23RD ST Street 1 Name Stop Condition-Street 1 StopSign N/A Street 2 Name Stop Condition-Street 2 N/A Remove & Replace Curb Ramp With Two New Directional Ramps or Equivalent.
