Access Compliance Report

Public Rights-of-Way

(Curb Ramps)

Intersection ID: 31369	Main Street: HAGERSTONE_WY	Cross Street: MCINTYRE_RIDGE_DR	Location: NE
ADA ID: 07DE4C6DCFCB	Ramp Type: BlendTrans2	Initial Pass/Fail: Fail	Overall Compliance: No
Severity Score: 12.5			
Codes/Mitigation Info/Possible Solution		Field Measurements/Component Compliance

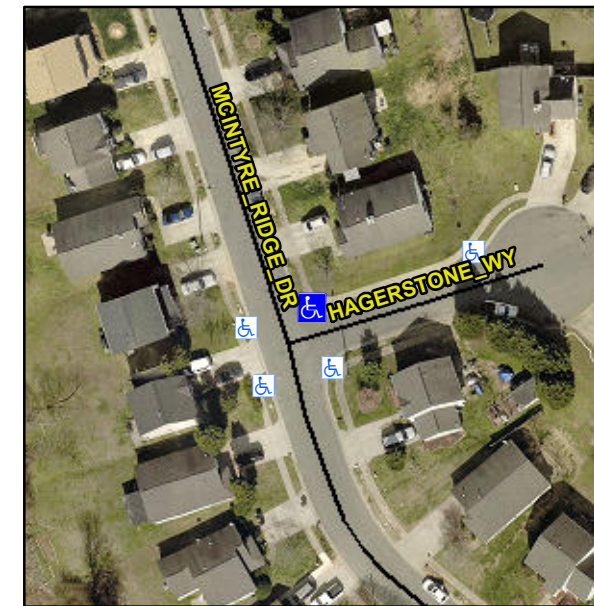
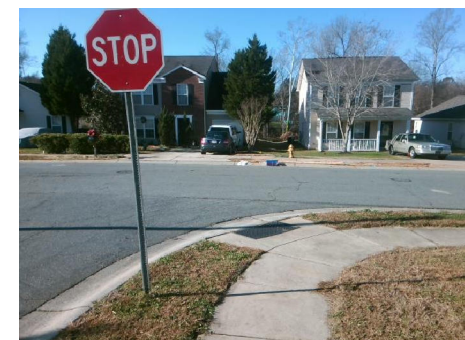
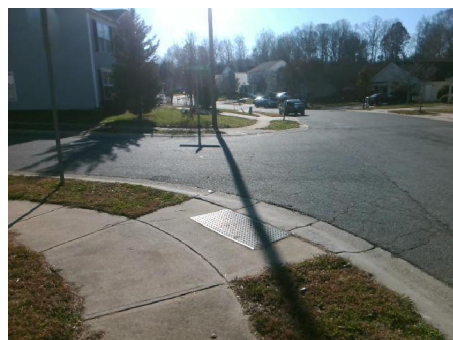
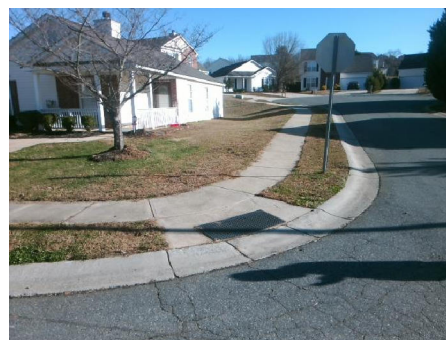
GTR GAP 1.5

R304.5.3

Compliance	Description	Data	Compliance	Description	Data
N/A	Ramp Length (in)	94.5	Yes	BlendTrans Slope (%)	4.0
Yes	Ramp Width (in)	52.5	No	BlendTrans XSlope (%)	5.1
N/A	Flare Type LT	N/A	N/A	Flare Type RT	N/A
N/A	Flare Slope LT (%)	N/A	N/A	Flare Slope RT (%)	N/A
N/A	Flare Traversable LT?	N/A	N/A	Flare Traversable RT?	N/A
N/A	Landing Length (in)	N/A	N/A	DWS Provided?	N/A
N/A	Landing Width (in)	N/A	N/A	DWS Contrast?	N/A
N/A	Landing Slope (%)	N/A	N/A	DWS Length (in)	N/A
N/A	Landing X Slope (%)	N/A	N/A	DWS Full Width?	N/A
N/A	Landing Curb? (Y/N)	N/A	N/A	DWS Offset (in)	N/A
N/A	Shared Landing?	N/A			
N/A	Gutter Ponding?	N/A	N/A	Gutter Slope (%)	N/A
N/A	Gutter Lip Ht (in)	0.5	N/A	Gutter X Slope (%)	N/A
N/A	Painted X Walk1?	No	N/A	Painted X Walk2?	No
	X Walk 1 Direction	To W		X Walk 2 Direction	To SE
	X Walk 1 Width (in)	N/A		X Walk 2 Width (in)	N/A
	X Walk 1 Slope (%)	0.6		X Walk 2 Slope (%)	2.6
	X Walk 1 X Slope (%)	1.6		X Walk 2 X Slope (%)	2.1

N/A	Ramp inside XWalk1?	N/A	N/A	Ramp inside XWalk2?	N/A
	Road Slope (%)	2.6		Clear Space?	N/A
	Road X Slope (%)	2.7	N/A	Clear Space to XWalk (in)	N/A
N/A	Any Obstructions?	N/A	N/A	Storm Grate/Utility Hazard?	N/A
	Obstruction Type			Storm Grate/Utility Type	
		N/A			N/A
			Yes	Surface Condition? (G/P)	Good
			N/A	Curb Slope (%)	4.7

Possible Solutions:

Remove & Replace Curb Ramp With Two New Directional Ramps or Equivalent.

Total Cost: \$ 3200.00
