## Access Compliance Report Public Rights-of-Way (Curb Ramps)

Intersection ID: 50099Main Street:SUNRISE\_VIEW\_DRCross Street:GRIERS\_PASTURE\_DRLocation:NWADA ID: 07EE1B42A645Ramp Type:PerpDiagInitial Pass/Fail:FailOverall Compliance:NoSeverity Score:10

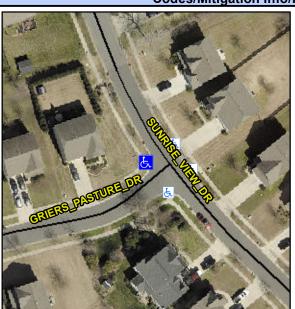
Not Found, R304.5.1, R304.5.3

Compliance Description Data Compliance Description Data Yes N/A Ramp Length (in) 86.0 Ramp Slope (%) 5.6 No Ramp XSlope (%) No Ramp Width (in) 36.0 2.6 N/A N/A Flare Type LT N/A Flare Type RT N/A N/A N/A N/A Flare Slope RT (%) N/A Flare Slope LT (%) N/A Flare Traversable LT? N/A N/A Flare Traversable RT? N/A N/A N/A N/A DWS Provided? N/A Landing Length (in) N/A Landing Width (in) N/A N/A **DWS Contrast?** N/A N/A N/A N/A Landing Slope (%) DWS Length (in) N/A N/A Landing X Slope (%) N/A N/A DWS Full Width? N/A N/A Landing Curb? (Y/N) N/A N/A DWS Offset (in) N/A N/A N/A Shared Landing? N/A **Gutter Ponding?** N/A N/A Gutter Slope (%) N/A N/A Gutter Lip Ht (in) N/A N/A Gutter X Slope (%) N/A N/A Painted X Walk1? No N/A Painted X Walk2? No X Walk 1 Direction To SE X Walk 2 Direction To NE N/A N/A N/A N/A X Walk 1 Width (in) X Walk 2 Width (in) X Walk 1 Slope (%) 3.7 X Walk 2 Slope (%) 2.1 X Walk 1 X Slope (%) 0.9 X Walk 2 X Slope (%) 2.2 N/A N/A N/A Ramp inside XWalk2? N/A Ramp inside XWalk1? Road Slope (%) 0.8 N/A Clear Space? N/A N/A Road X Slope (%) 2.3 Clear Space to XWalk (in) N/A N/A N/A N/A Any Obstructions? Storm Grate/Utility Hazard? N/A **Obstruction Type** Storm Grate/Utility Type N/A N/A

Remove & Replace Curb Ramp With Two New Directional Ramps or Equivalent.
