Access Compliance Report

Public Rights-of-Way

(Curb Ramps)

Intersection ID: 19204	Main Street: CHARTER_PL	Cross Street: ROCKY_FALLS_RD	Location: W
ADA ID: 07F673BE6DBC	Ramp Type: BlendTrans2	Initial Pass/Fail: Fail	Overall Compliance: No
Severity Score: 36.25			
Codes/Mitigation Info/Possible Solution		Field Measurements/Component Compliance

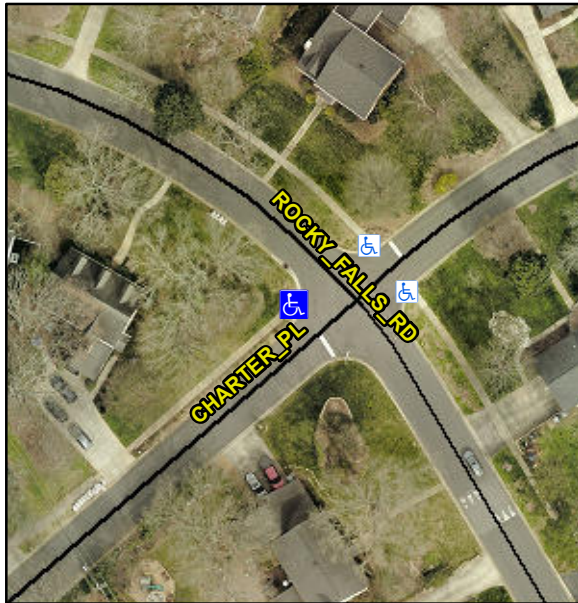
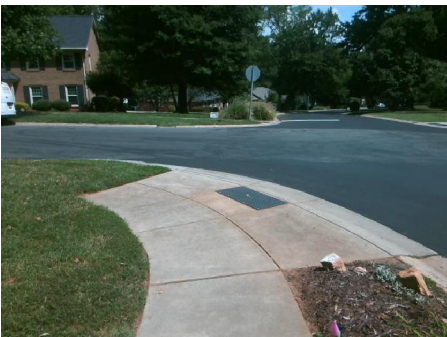
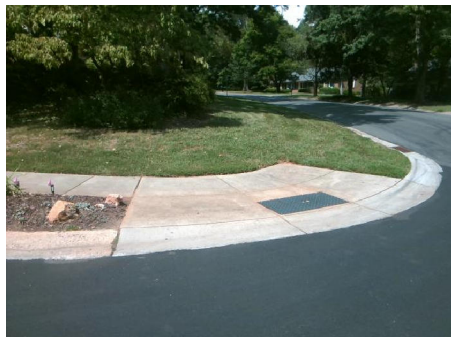
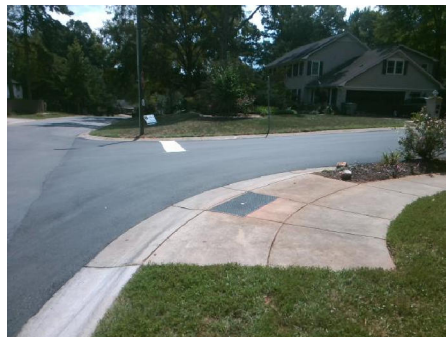
Not Found, R304.5.1, R304.5.3

Compliance	Description	Data	Compliance	Description	Data
N/A	Ramp Length (in)	96.0	Yes	BlendTrans Slope (%)	2.2
No	Ramp Width (in)	30.0	No	BlendTrans XSlope (%)	2.3
N/A	Flare Type LT	N/A	N/A	Flare Type RT	N/A
N/A	Flare Slope LT (%)	N/A	N/A	Flare Slope RT (%)	N/A
N/A	Flare Traversable LT?	N/A	N/A	Flare Traversable RT?	N/A
N/A	Landing Length (in)	N/A	N/A	DWS Provided?	N/A
N/A	Landing Width (in)	N/A	N/A	DWS Contrast?	N/A
N/A	Landing Slope (%)	N/A	N/A	DWS Length (in)	N/A
N/A	Landing X Slope (%)	N/A	N/A	DWS Full Width?	N/A
N/A	Landing Curb? (Y/N)	N/A	N/A	DWS Offset (in)	N/A
N/A	Shared Landing?	N/A			
N/A	Gutter Ponding?	N/A	N/A	Gutter Slope (%)	N/A
N/A	Gutter Lip Ht (in)	N/A	N/A	Gutter X Slope (%)	N/A
N/A	Painted X Walk1?	No	N/A	Painted X Walk2?	No
	X Walk 1 Direction	To SE		X Walk 2 Direction	To NE
	X Walk 1 Width (in)	N/A		X Walk 2 Width (in)	N/A
	X Walk 1 Slope (%)	2.2		X Walk 2 Slope (%)	1.5
	X Walk 1 X Slope (%)	1.7		X Walk 2 X Slope (%)	1.3

N/A	Ramp inside XWalk1?	N/A	N/A	Ramp inside XWalk2?	N/A
	Road Slope (%)	1.1		Clear Space?	N/A
	Road X Slope (%)	0.7	N/A	Clear Space to XWalk (in)	N/A
N/A	Any Obstructions?	N/A	N/A	Storm Grate/Utility Hazard?	N/A
	Obstruction Type			Storm Grate/Utility Type	
		N/A			N/A
			Yes	Surface Condition? (G/P)	Good
			No	Curb Slope (%)	9.1

Possible Solutions:

Remove & Replace Curb Ramp With Two New Directional Ramps or Equivalent.

Total Cost: \$ **3200.00**
