Intersection ID: 9372	Main Street: N_SMALLWOOD_PL	Cross Street: SELDON_DR	Location:	S
ADA ID: 0826BA45F722	Ramp Type: Perp	Initial Pass/Fail: Fail	Overall Compliance: No	Severity Score: 10

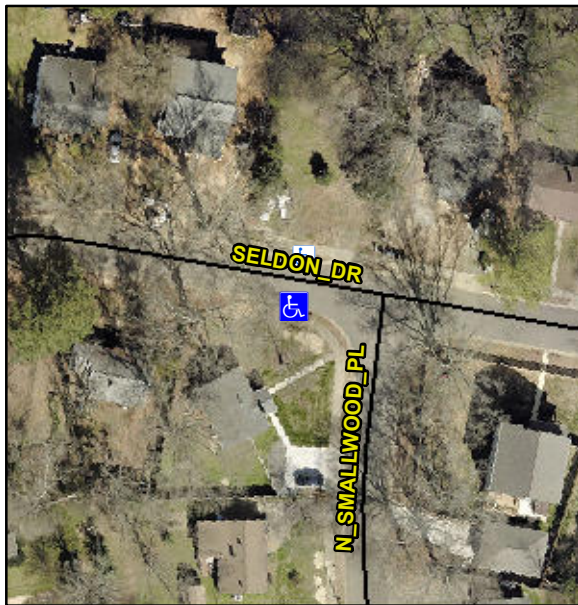
Not Found, R304.5.1

Possible Solutions:			Compliance	Description	Data	Compliance	Description	Data
Remove & Replace Entire Ramp.			N/A	Ramp Length (in)	48.0	Yes	Ramp Slope (%)	5.2
			No	Ramp Width (in)	47.0	Yes	Ramp XSlope (%)	4.0
			N/A	Flare Type LT	N/A	N/A	Flare Type RT	N/A
			N/A	Flare Slope LT (%)	N/A	N/A	Flare Slope RT (%)	N/A
			N/A	Flare Traversable LT?	N/A	N/A	Flare Traversable RT?	N/A
			N/A	Landing Length (in)	N/A	N/A	DWS Provided?	N/A
			N/A	Landing Width (in)	N/A	N/A	DWS Contrast?	N/A
			N/A	Landing Slope (%)	N/A	N/A	DWS Length (in)	N/A
			N/A	Landing X Slope (%)	N/A	N/A	DWS Full Width?	N/A
			N/A	Landing Curb? (Y/N)	N/A	N/A	DWS Offset (in)	N/A
Surveyor Notes: N/A			N/A	Shared Landing?	N/A			
			N/A	Gutter Ponding?	N/A	N/A	Gutter Slope (%)	N/A
			N/A	Gutter Lip Ht (in)	1.0	N/A	Gutter X Slope (%)	N/A
			N/A	Painted X Walk1?	No	N/A	Painted X Walk2?	N/A
				X Walk 1 Direction	To N		X Walk 2 Direction	N/A
			N/A	X Walk 1 Width (in)	N/A	N/A	X Walk 2 Width (in)	N/A

X Walk 1 Slope (%)	5.7		X Walk 2 Slope (%)	N/A
				X Walk 1 X Slope (%)	6.1		X Walk 2 X Slope (%)	N/A
			N/A	Ramp inside XWalk1?	N/A	N/A	Ramp inside XWalk2?	N/A
				Road Slope (%)	N/A	N/A	Clear Space?	N/A
PROW/ADA: Not Found, R304.5.1				Road X Slope (%)	N/A	N/A	Clear Space to XWalk (in)	N/A
			N/A	Any Obstructions?	N/A	N/A	Storm Grate/Utility Hazard?	N/A
				Obstruction Type			Storm Grate/Utility Type	
					N/A			N/A
						Yes	Surface Condition? (G/P)	Good
Total Cost:			\$	1850.00

Remove & Replace Entire Ramp.
