Access Compliance Report

Public Rights-of-Way

(Curb Ramps)

Intersection ID: 27236	Main Street: BALLANTYNE CORPORATE PL	Cross Street: BRIXHAM HILL AV	Location: E
ADA ID: 08270455DB46	Ramp Type: Perp	Initial Pass/Fail: Fail	Overall Compliance: No
			Severity Score: 1.25
Codes/Mitigation Info/Possible Solution		Field Measurements/Component Compliance

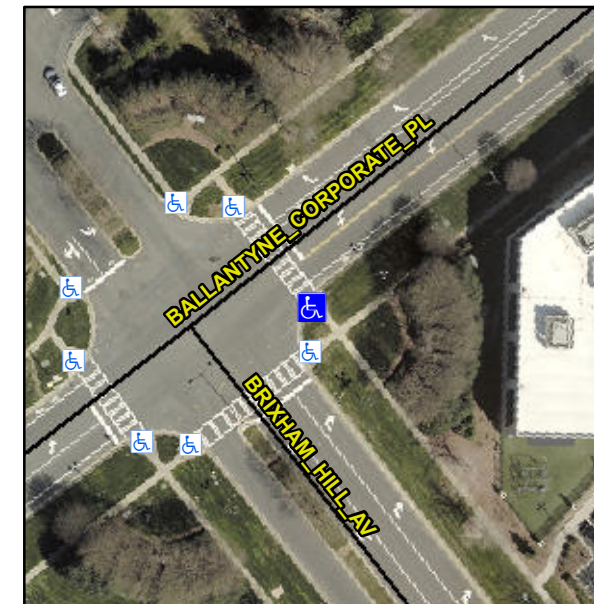
R304.5.3

Compliance	Description	Data	Compliance	Description	Data
N/A	Ramp Length (in)	108.0	Yes	Ramp Slope (%)	7.5
Yes	Ramp Width (in)	48.0	No	Ramp XSlope (%)	3.6
N/A	Flare Type LT	N/A	N/A	Flare Type RT	N/A
N/A	Flare Slope LT (%)	N/A	N/A	Flare Slope RT (%)	N/A
N/A	Flare Traversable LT?	N/A	N/A	Flare Traversable RT?	N/A
N/A	Landing Length (in)	N/A	N/A	DWS Provided?	N/A
N/A	Landing Width (in)	N/A	N/A	DWS Contrast?	N/A
N/A	Landing Slope (%)	N/A	N/A	DWS Length (in)	N/A
N/A	Landing X Slope (%)	N/A	N/A	DWS Full Width?	N/A
N/A	Landing Curb? (Y/N)	N/A	N/A	DWS Offset (in)	N/A
N/A	Shared Landing?	N/A			
N/A	Gutter Ponding?	N/A	N/A	Gutter Slope (%)	N/A
N/A	Gutter Lip Ht (in)	N/A	N/A	Gutter X Slope (%)	N/A
N/A	Painted X Walk1?	Yes	N/A	Painted X Walk2?	N/A
	X Walk 1 Direction	To NW		X Walk 2 Direction	N/A
N/A	X Walk 1 Width (in)	112.0	N/A	X Walk 2 Width (in)	N/A
	X Walk 1 Slope (%)	4.2		X Walk 2 Slope (%)	N/A
	X Walk 1 X Slope (%)	0.7		X Walk 2 X Slope (%)	N/A

N/A	Ramp inside XWalk1?	Yes	N/A	Ramp inside XWalk2?	N/A
	Road Slope (%)	N/A	N/A	Clear Space?	N/A
	Road X Slope (%)	N/A	N/A	Clear Space to XWalk (in)	N/A
N/A	Any Obstructions?	N/A	N/A	Storm Grate/Utility Hazard?	N/A
	Obstruction Type			Storm Grate/Utility Type	
		N/A			N/A
			Yes	Surface Condition? (G/P)	Good

Possible Solutions:

Remove & Replace Entire Ramp.
