Access Compliance Report Public Rights-of-Way (Curb Ramps)

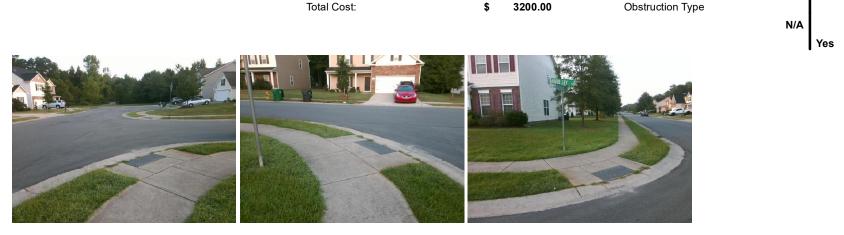
· · · · · · · · · · · · · · · · · · ·										
Intersection ID: 46683	ntersection ID: 46683 Main Street: GOLDFIELDS_DR			reet:	ABODE_LILY_LN	Location:	SE			
ADA ID: 082C83CDE3D0	DA ID: 082C83CDE3D0 Ramp Type: PerpDiag			ss/Fa	nil: Fail Overall C	o Severity Score:	21.25			
Codes/Mitigation Info/Possible Solution				Field Measurements/Component Compliance						
Possible Solutions:				Compliance Description Data Complia			liance Description	Data		
	A V	Remove & Replace Curb Ramp W	-	N/A	Ramp Length (in)	98.5	No	Ramp Slope (%)	9.2	
		Two New Directional Ramps or		No	Ramp Width (in)	47.5		Ramp XSlope (%)	1.0	
		Equivalent.		N/A	Flare Type LT	N/A	N/A	Flare Type RT	N/A	
A A A A A A A A A A A A A A A A A A A	. I man			N/A	Flare Slope LT (%)	N/A	N/A	Flare Slope RT (%)	N/A	
	ALL REAL			V/A	Flare Traversable LT?	N/A	N/A	Flare Traversable RT?	N/A	
6	NEODE E			∿/A	Landing Length (in)	N/A	N/A	DWS Provided?	N/A

Surveyor Notes:		V/A	Landing Width (in)	N/A	N/A	DWS Contrast?	N/A	
				N/A	3 ()	N/A	N/A		N/A N/A	
		N/A			Landing Slope (%)			DWS Length (in)		
PROW/ADA: R304.5.1, R304.2.2				N/A	Landing X Slope (%)	N/A	N/A	DWS Full Width?	N/A	
				N/A	Landing Curb? (Y/N)	N/A	N/A	DWS Offset (in)	N/A	
				N/A	Shared Landing?	N/A				
			1	N/A	Gutter Ponding?	N/A	N/A	Gutter Slope (%)	N/A	
			١	N/A	Gutter Lip Ht (in)	N/A	N/A	Gutter X Slope (%)	N/A	
			1	N/A	Painted X Walk1?	No	N/A	Painted X Walk2?	No	
					X Walk 1 Direction	To N		X Walk 2 Direction	To W	
			1	N/A	X Walk 1 Width (in)	N/A	N/A	X Walk 2 Width (in)	N/A	
Street 1 Name	ABODE LILY LN				X Walk 1 Slope (%)	2.8		X Walk 2 Slope (%)	2.7	
Stop Condition-Street 2	StopSign				X Walk 1 X Slope (%)	1.3		X Walk 2 X Slope (%)	2.6	
Street 2 Name	GOLDFIELDS DR		1	N/A	Ramp inside XWalk1?	N/A	N/A	Ramp inside XWalk2?	N/A	
Stop Condition-Street 1	None				Road Slope (%)	1.7	N/A	Clear Space?	N/A

Road X Slope (%)	3.9	N/A	Clear Space to XWalk (in)	N/A	
				N/A	Any Obstructions?	N/A	N/A	Storm Grate/Utility Hazard?	N/A	
		Total Cost: \$ 3	200.00		Obstruction Type			Storm Grate/Utility Type		
		Ψ				N/A	1		N/A	
						17/4			10/5
