# Access Compliance Report

## Public Rights-of-Way

### (Curb Ramps)

| Intersection ID: 3448 | Main Street: W W T HARRIS BV TO I-77 RA SB | Location: SE |

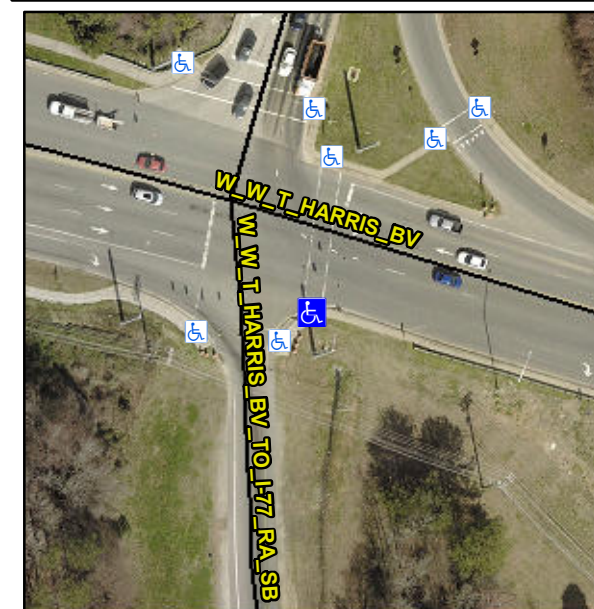
**RT RP < 5%**

**R304.3.2, R304.5.3**

| Compliance | Description | Data | Compliance | Description | Data |
|---|---|---|---|---|---|
| No | Ramp Slope LT (%) | 16.2 | Yes | Ramp Slope RT (%) | 0.0 |
| No | Ramp XSlope LT (%) | 2.1 | Yes | Ramp XSlope RT (%) | 0.5 |

**Remove & Replace Entire Ramp.**
