# Access Compliance Report

## Public Rights-of-Way (Curb Ramps)

| Intersection ID: 47811 | Main Street: NEVIN_GLEN_DR | Cross Street: STATESVILLE_RD | Location: SE |
| ADA ID: 0832FA6DD524 | Ramp Type: Directional1 | Initial Pass/Fail: Pass | Overall Compliance: No |

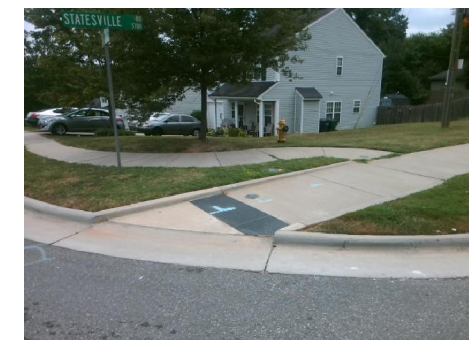
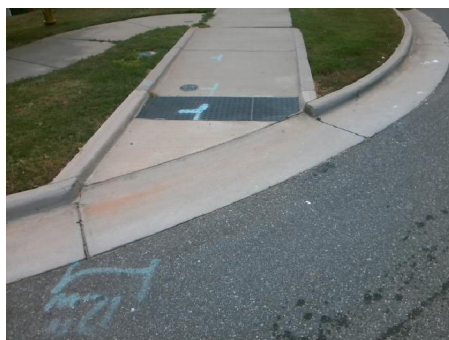
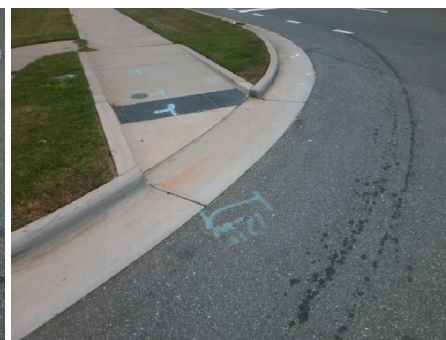
**Not Found, R304.5.3**

| Compliance | Description | Data | Compliance | Description | Data |
|---|---|---|---|---|---|
| Yes | Gutter Lip Ht (in) | 0.0 | No | Gutter X Slope (%) | 2.2 |

**Remove & Replace Entire Ramp.  
Remove & Replace Gutter.**
