# Access Compliance Report

## Public Rights-of-Way

### (Curb Ramps)

| Intersection ID: 32125 | Main Street: FALLS_LAKE_DR | Cross Street: THURLES_CT | Location: SW |

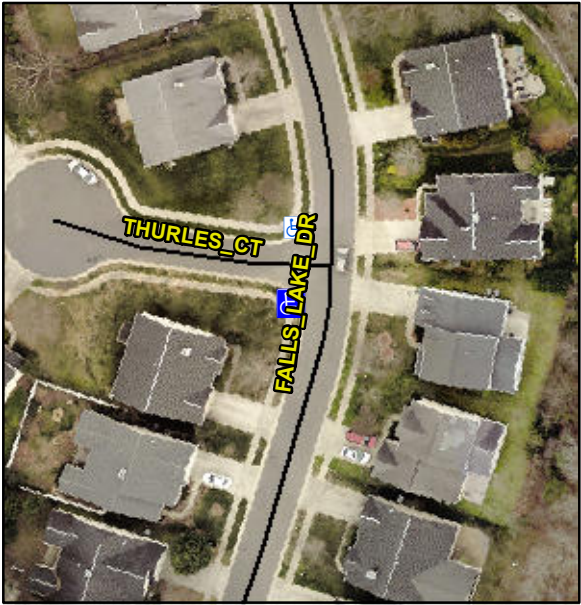
| ADA ID: 083937C72947 | Ramp Type: Perp | Initial Pass/Fail: Fail | Overall Compliance: No |

| Codes/Mitigation Info/Possible Solution | | | Field Measurements/Component Compliance | | |
|---|--|---|---|---|---|
| | | | <b>No</b> | Ramp Width (in) | 29.0 |
| <p>Surveyor Notes:</p> <p><b>N/A</b></p> <p>PROW/ADA:</p> <p><b>Not Found, R304.5.1</b></p> | | | <b>N/A</b> | Flare Type RT | N/A |

| Codes/Mitigation Info/Possible Solution | | | Field Measurements/Component Compliance | | |
|---|--|---|---|---|---|
| | <b>Remove &amp; Replace Entire Ramp.</b> | | <b>Yes</b> | Ramp Length (in) | 47.0 |
| Total Cost: | | \$ 1850.00 | | | |
