# Access Compliance Report

## Public Rights-of-Way

### (Curb Ramps)

Intersection ID: 48563	Main Street: MASON_MILL_PL	Cross Street: HAINES_MILL_RD	Location: NE
ADA ID: 085553F16AB8	Ramp Type: Perp	Initial Pass/Fail: Fail	Overall Compliance: No
		Severity Score: 12.5

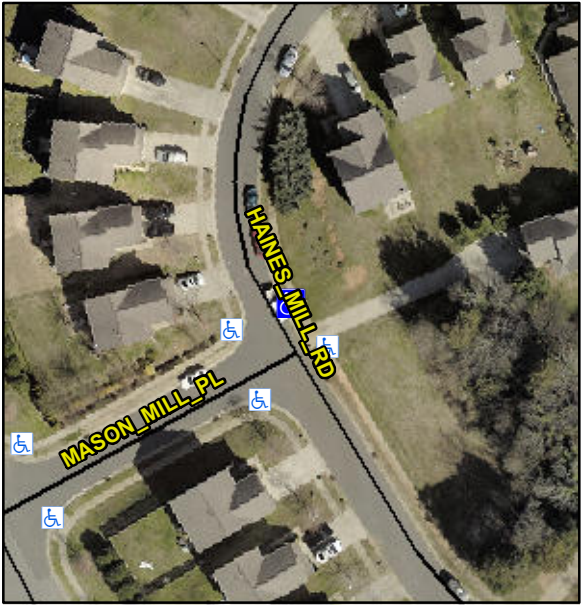
Possible Solutions:		<b>Compliance</b>	<b>Description</b>	<b>Data</b>
	<b>Remove &amp; Replace Entire Ramp.</b>		<b>No</b>	Ramp Length (in)	50.0
			<b>Yes</b>	Ramp Width (in)	48.0
			<b>N/A</b>	Flare Type LT	N/A
			<b>N/A</b>	Flare Slope LT (%)	N/A
			<b>N/A</b>	Flare Traversable LT?	N/A
			<b>N/A</b>	Landing Length (in)	N/A
			<b>N/A</b>	Landing Width (in)	N/A
			<b>N/A</b>	Landing Slope (%)	N/A
			<b>N/A</b>	Landing X Slope (%)	N/A
<p>Surveyor Notes:</p> <p><b>N/A</b></p> <p>PROW/ADA:</p> <p><b>Not Found, R304.2.2</b></p>			<b>N/A</b>	Flare Type RT	N/A
			<b>N/A</b>	Flare Slope RT (%)	N/A
			<b>N/A</b>	Flare Traversable RT?	N/A
			<b>N/A</b>	DWS Provided?	N/A
			<b>N/A</b>	DWS Contrast?	N/A
			<b>N/A</b>	DWS Length (in)	N/A
			<b>N/A</b>	DWS Full Width?	N/A
			<b>N/A</b>	DWS Offset (in)	N/A
			<b>N/A</b>	Shared Landing?	N/A
