Intersection ID: 2715	Main Street: CROWNISTA_DR	Cross Street: DAWN Mist_LN	Location:	E
ADA ID: 085B0EE470A3	Ramp Type: PerpDiag	Initial Pass/Fail: Fail	Overall Compliance: No	Severity Score: 8.75

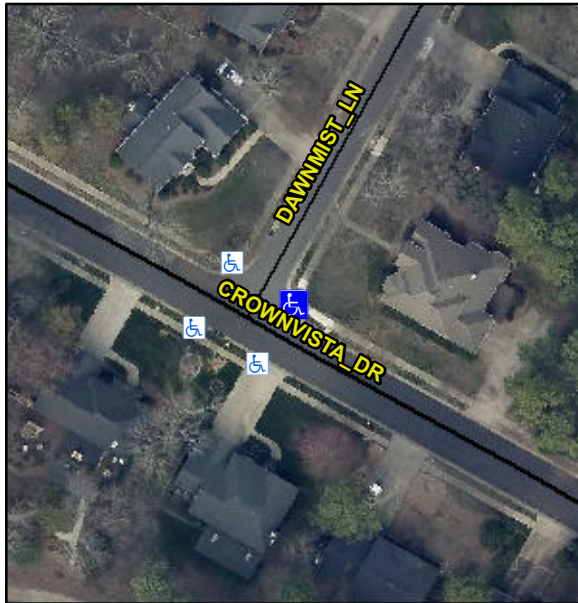
Compliance	Description	Data	Compliance	Description	Data
N/A	Ramp Length (in)	45.0	Yes	Ramp Slope (%)	6.0
No	Ramp Width (in)	40.0	Yes	Ramp XSlope (%)	1.1
N/A	Flare Type LT	N/A	N/A	Flare Type RT	N/A
N/A	Flare Slope LT (%)	N/A	N/A	Flare Slope RT (%)	N/A
N/A	Flare Traversable LT?	N/A	N/A	Flare Traversable RT?	N/A
N/A	Landing Length (in)	N/A	N/A	DWS Provided?	N/A
N/A	Landing Width (in)	N/A	N/A	DWS Contrast?	N/A
N/A	Landing Slope (%)	N/A	N/A	DWS Length (in)	N/A
N/A	Landing X Slope (%)	N/A	N/A	DWS Full Width?	N/A
N/A	Landing Curb? (Y/N)	N/A	N/A	DWS Offset (in)	N/A
N/A	Shared Landing?	N/A			
N/A	Gutter Ponding?	N/A	N/A	Gutter Slope (%)	N/A
N/A	Gutter Lip Ht (in)	N/A	N/A	Gutter X Slope (%)	N/A
N/A	Painted X Walk1?	No	N/A	Painted X Walk2?	No
	X Walk 1 Direction	To NW		X Walk 2 Direction	To SW
N/A	X Walk 1 Width (in)	N/A	N/A	X Walk 2 Width (in)	N/A
	X Walk 1 Slope (%)	1.8		X Walk 2 Slope (%)	3.7
	X Walk 1 X Slope (%)	2.7		X Walk 2 X Slope (%)	2.2

N/A	Ramp inside XWalk1?	N/A	N/A	Ramp inside XWalk2?	N/A
	Road Slope (%)	0.0	N/A	Clear Space?	N/A
	Road X Slope (%)	1.9	N/A	Clear Space to XWalk (in)	N/A
N/A	Any Obstructions?	N/A	N/A	Storm Grate/Utility Hazard?	N/A
	Obstruction Type			Storm Grate/Utility Type	
		N/A			N/A
			Yes	Surface Condition? (G/P)	Good

**Remove & Replace Curb Ramp With Two New Directional Ramps or Equivalent.**
