# Access Compliance Report

## Public Rights-of-Way

### (Curb Ramps)

Intersection ID: 15283	Main Street: BLANDWOOD_DR	Cross Street: CLANTON_RD	Location: S
ADA ID: 087351ABAACB	Ramp Type: PerpDiag	Initial Pass/Fail: Fail	Overall Compliance: No
Severity Score: 21.25			
Codes/Mitigation Info/Possible Solution		Field Measurements/Component Compliance

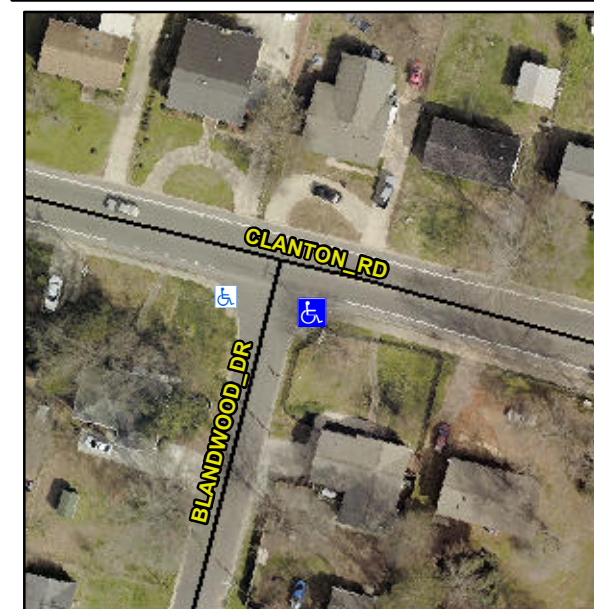
**Not Found, R304.5.1, R304.2.2**

Compliance	Description	Data	Compliance	Description	Data
N/A	Ramp Length (in)	60.0	No	Ramp Slope (%)	10.4
No	Ramp Width (in)	41.0	Yes	Ramp XSlope (%)	1.9
N/A	Flare Type LT	N/A	N/A	Flare Type RT	N/A
N/A	Flare Slope LT (%)	N/A	N/A	Flare Slope RT (%)	N/A
N/A	Flare Traversable LT?	N/A	N/A	Flare Traversable RT?	N/A
N/A	Landing Length (in)	N/A	N/A	DWS Provided?	N/A
N/A	Landing Width (in)	N/A	N/A	DWS Contrast?	N/A
N/A	Landing Slope (%)	N/A	N/A	DWS Length (in)	N/A
N/A	Landing X Slope (%)	N/A	N/A	DWS Full Width?	N/A
N/A	Landing Curb? (Y/N)	N/A	N/A	DWS Offset (in)	N/A
N/A	Shared Landing?	N/A			
N/A	Gutter Ponding?	N/A	N/A	Gutter Slope (%)	N/A
N/A	Gutter Lip Ht (in)	N/A	N/A	Gutter X Slope (%)	N/A
N/A	Painted X Walk1?	No	N/A	Painted X Walk2?	No
	X Walk 1 Direction	To NE		X Walk 2 Direction	To W
N/A	X Walk 1 Width (in)	N/A	N/A	X Walk 2 Width (in)	N/A
	X Walk 1 Slope (%)	3.8		X Walk 2 Slope (%)	2.0
	X Walk 1 X Slope (%)	1.0		X Walk 2 X Slope (%)	3.9

N/A	Ramp inside XWalk1?	N/A	N/A	Ramp inside XWalk2?	N/A
	Road Slope (%)	2.8	N/A	Clear Space?	N/A
	Road X Slope (%)	2.9	N/A	Clear Space to XWalk (in)	N/A
N/A	Any Obstructions?	N/A	N/A	Storm Grate/Utility Hazard?	N/A
	Obstruction Type			Storm Grate/Utility Type	
		N/A			N/A
			Yes	Surface Condition? (G/P)	Good

Possible Solutions:

**Remove & Replace Curb Ramp With Two New Directional Ramps or Equivalent.**
