Access Compliance Report

Public Rights-of-Way

(Curb Ramps)

| Intersection ID: 50335 | Main Street: MILLIE_LN | Cross Street: LEVY_WY | Location: NW |

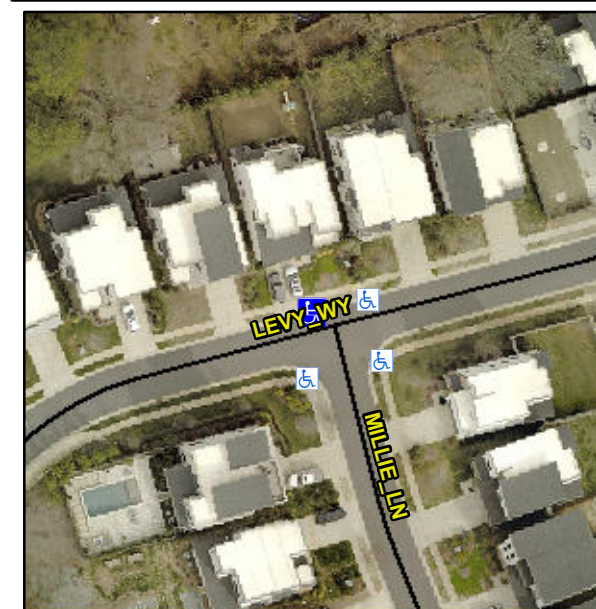
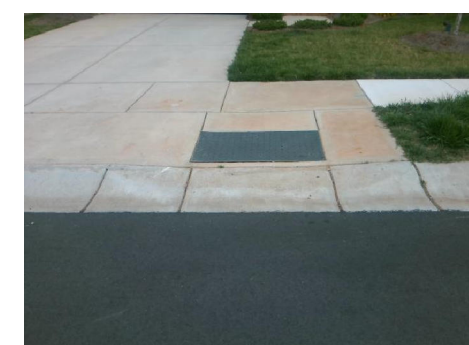
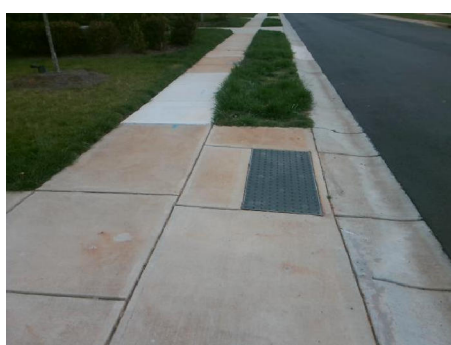
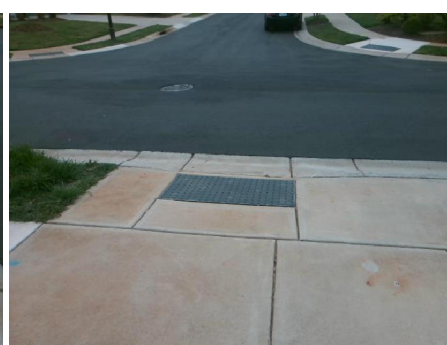
| ADA ID: 088B859ACDEC | Ramp Type: Perp | Initial Pass/Fail: Fail | Overall Compliance: No |
| Severity Score: 10 | | | |

Not Found, R304.5.1, R304.5.3

| Compliance | Description | Data | Compliance | Description | Data |
|---|---|---|---|---|---|
| N/A | Ramp Length (in) | 48.0 | Yes | Ramp Slope (%) | 7.7 |
| No | Ramp Width (in) | 47.0 | No | Ramp XSlope (%) | 4.2 |

Remove & Replace Entire Ramp.
