Access Compliance Report

Public Rights-of-Way

(Curb Ramps)

Intersection ID: 30140	Main Street: HARLAND_ST	Cross Street: STREATOR_CT	Location: SE
ADA ID: 08BB00CA72B3	Ramp Type: PerpDiag	Initial Pass/Fail: Fail	Overall Compliance: No
Severity Score: 12.5			
Codes/Mitigation Info/Possible Solution		Field Measurements/Component Compliance

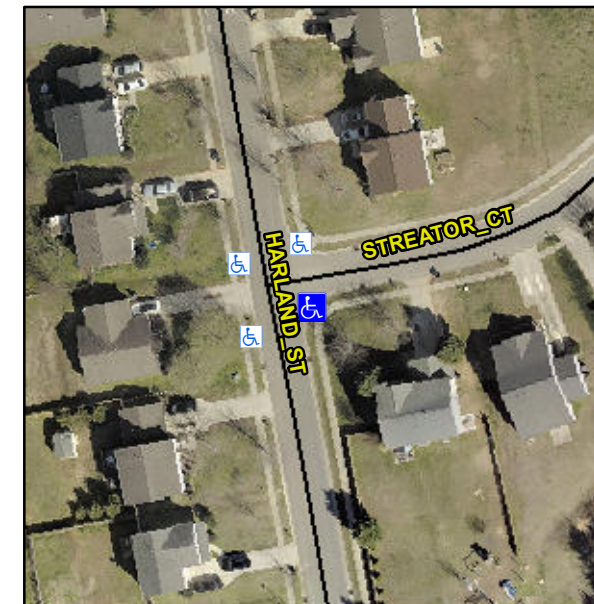
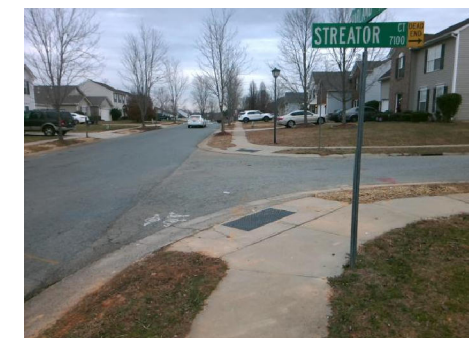
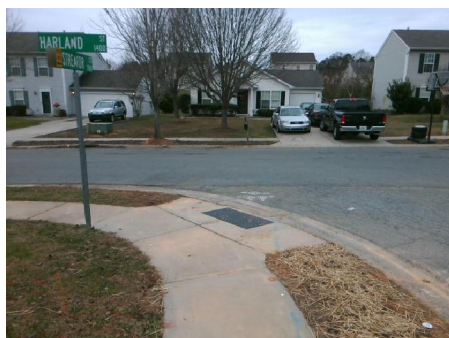
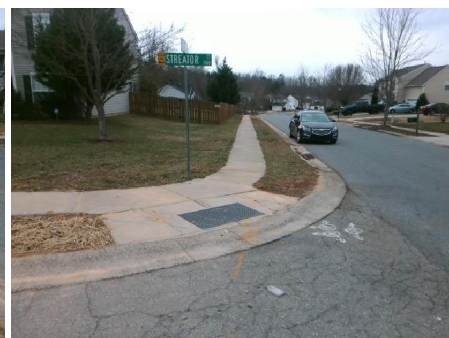
Not Found, R304.5.3

Compliance	Description	Data	Compliance	Description	Data
N/A	Ramp Length (in)	48.0	Yes	Ramp Slope (%)	6.1
Yes	Ramp Width (in)	48.0	No	Ramp XSlope (%)	5.2
N/A	Flare Type LT	N/A	N/A	Flare Type RT	N/A
N/A	Flare Slope LT (%)	N/A	N/A	Flare Slope RT (%)	N/A
N/A	Flare Traversable LT?	N/A	N/A	Flare Traversable RT?	N/A
N/A	Landing Length (in)	N/A	N/A	DWS Provided?	N/A
N/A	Landing Width (in)	N/A	N/A	DWS Contrast?	N/A
N/A	Landing Slope (%)	N/A	N/A	DWS Length (in)	N/A
N/A	Landing X Slope (%)	N/A	N/A	DWS Full Width?	N/A
N/A	Landing Curb? (Y/N)	N/A	N/A	DWS Offset (in)	N/A
N/A	Shared Landing?	N/A			
N/A	Gutter Ponding?	N/A	N/A	Gutter Slope (%)	N/A
N/A	Gutter Lip Ht (in)	N/A	N/A	Gutter X Slope (%)	N/A
N/A	Painted X Walk1?	No	N/A	Painted X Walk2?	No
	X Walk 1 Direction	To N		X Walk 2 Direction	To W
N/A	X Walk 1 Width (in)	N/A	N/A	X Walk 2 Width (in)	N/A
	X Walk 1 Slope (%)	2.0		X Walk 2 Slope (%)	1.2
	X Walk 1 X Slope (%)	0.1		X Walk 2 X Slope (%)	2.4

N/A	Ramp inside XWalk1?	N/A	N/A	Ramp inside XWalk2?	N/A
	Road Slope (%)	4.0	N/A	Clear Space?	N/A
	Road X Slope (%)	2.6	N/A	Clear Space to XWalk (in)	N/A
N/A	Any Obstructions?	N/A	N/A	Storm Grate/Utility Hazard?	N/A
	Obstruction Type			Storm Grate/Utility Type	
		N/A			N/A
		Yes		Surface Condition? (G/P)	Good

Remove & Replace Curb Ramp With Two New Directional Ramps or Equivalent.
