Access Compliance Report

Public Rights-of-Way

(Curb Ramps)

Intersection ID: N/A	Main Street: CENTRAL_AV	Cross Street: KILBORNE_DR	Location: NW
ADA ID: 08C478C1CDC5	Ramp Type: Combination1	Initial Pass/Fail: Fail	Overall Compliance: No
Severity Score: 10			
Codes/Mitigation Info/Possible Solution		Field Measurements/Component Compliance

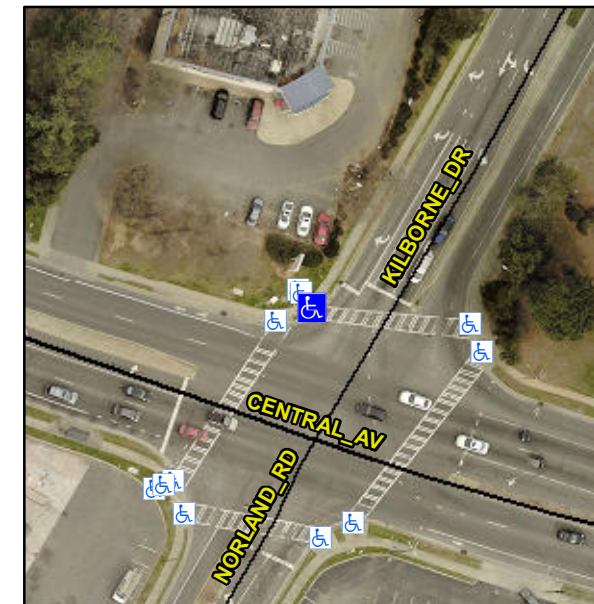
Not Found, R304.5.1, R304.5.3

Compliance	Description	Data	Compliance	Description	Data
N/A	Ramp Length LT (in)	52.0	N/A	Ramp Length RT (in)	56.0
Yes	Ramp Width LT (in)	59.5	Yes	Ramp Width RT (in)	59.5
Yes	Ramp Slope LT (%)	7.3	Yes	Ramp Slope RT (%)	6.1
No	Ramp XSlope LT (%)	2.1	Yes	Ramp XSlope RT (%)	2.0
N/A	Ramp Length (in)	24.0	Yes	Ramp Slope (%)	4.9
No	Ramp Width (in)	43.0	Yes	Ramp XSlope (%)	1.4
N/A	Flare Type LT	N/A	N/A	Flare Type RT	N/A
N/A	Flare Slope LT (%)	N/A	N/A	Flare Slope RT (%)	N/A
N/A	Flare Traversable LT?	N/A	N/A	Flare Traversable RT?	N/A
N/A	Landing Length (in)	N/A	N/A	DWS Provided?	N/A
N/A	Landing Width (in)	N/A	N/A	DWS Contrast?	N/A
N/A	Landing Slope (%)	N/A	N/A	DWS Length (in)	N/A
N/A	Landing X Slope (%)	N/A	N/A	DWS Full Width?	N/A
N/A	Landing Curb? (Y/N)	N/A	N/A	DWS Offset (in)	N/A
N/A	Shared Landing?	N/A			
N/A	Gutter Ponding?	N/A	N/A	Gutter Slope (%)	N/A
N/A	Gutter Lip Ht (in)	N/A	N/A	Gutter X Slope (%)	N/A
N/A	Painted X Walk1?	Yes	N/A	Painted X Walk2?	N/A

X Walk 1 Direction	To E		X Walk 2 Direction	N/A
	X Walk 1 Width (in)	77.0		X Walk 2 Width (in)	N/A
	X Walk 1 Slope (%)	0.3		X Walk 2 Slope (%)	N/A
	X Walk 1 X Slope (%)	0.2		X Walk 2 X Slope (%)	N/A
N/A	Ramp inside XWalk1?	Yes	N/A	Ramp inside XWalk2?	N/A
	Road Slope (%)	N/A		Clear Space?	N/A
	Road X Slope (%)	N/A	N/A	Clear Space to XWalk (in)	N/A
			N/A	Any Obstruction?	N/A
				Obstruction Type	N/A
			N/A	Storm Grate/Utility Hazard?	N/A
				Storm Grate/Utility Type	N/A
					N/A
Yes	Surface Condition? (G/P)	Good			
	Curb Slope (%)	10.8

Remove & Replace Entire Ramp.
