## **Access Compliance Report Public Rights-of-Way** (Curb Ramps)

Intersection ID: 10477 Main Street: HAMILTON\_ST **Cross Street: POLK\_ST** Location:

ADA ID: 08CCB6A78708 Ramp Type: BlendTrans2 Initial Pass/Fail: Fail **Overall Compliance: No Severity Score:** 1.25

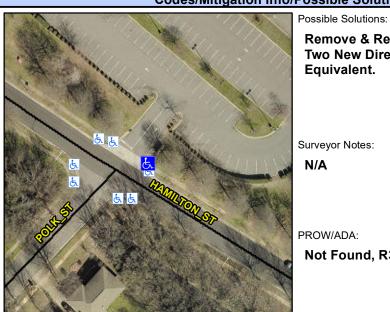
Not Found, R304.5.3

Field Measurements/Component Compliance						
Comp	liance Description	Data	Comp	liance Description	Data	
N/A	Ramp Length (in)	51.0	Yes	BlendTrans Slope (%)	3.3	
Yes	Ramp Width (in)	67.0	No	BlendTrans XSlope (%)	2.4	
N/A	Flare Type LT	Sloped	N/A	Flare Type RT	Sloped	
N/A	Flare Slope LT (%)	11.4	N/A	Flare Slope RT (%)	2.9	
N/A	Flare Traversable LT?	Yes	N/A	Flare Traversable RT?	No	
N/A	Landing Length (in)	N/A	N/A	DWS Provided?	Yes	
N/A	Landing Width (in)	N/A	N/A	DWS Contrast?	Yes	
N/A	Landing Slope (%)	N/A	N/A	DWS Length (in)	24.0	
N/A	Landing X Slope (%)	N/A	N/A	DWS Full Width?	No	
N/A	Landing Curb? (Y/N)	No	N/A	DWS Offset (in)	10.5	
N/A	Shared Landing?	No				
N/A	Gutter Ponding?	No	N/A	Gutter Slope (%)	0.4	
N/A	Gutter Lip Ht (in)	1.0	N/A	Gutter X Slope (%)	1.9	
N/A	Painted X Walk1?	No	N/A	Painted X Walk2?	N/A	
	X Walk 1 Direction	To NW		X Walk 2 Direction	N/A	
	X Walk 1 Width (in)	N/A		X Walk 2 Width (in)	N/A

X Walk 1 Slope (%)	0.7		X Walk 2 Slope (%)	N/A	
	X Walk 1 X Slope (%)	0.8		X Walk 2 X Slope (%)	N/A	
N/A	Ramp inside XWalk1?	N/A	N/A	Ramp inside XWalk2?	N/A	
	Road Slope (%)	0.8		Clear Space?	Yes	
	Road X Slope (%)	0.7	N/A	Clear Space to XWalk (in)	N/A	
N/A	Any Obstructions?	No	N/A	Storm Grate/Utility Hazard?	No	
	Obstruction Type			Storm Grate/Utility Type		
		N/A			N/A	
			Yes	Surface Condition? (G/P)	Good	
			No	Curb Slope (%)	10.2

**POLK ST** Street 1 Name Stop Condition-Street 1 StopSign Street 2 Name N/A Stop Condition-Street 2 N/A **Remove & Replace Curb Ramp With Two New Directional Ramps or** Equivalent.
