## **Access Compliance Report Public Rights-of-Way** (Curb Ramps)

Intersection ID: 14455 Main Street: EAST BV Cross Street: WINTHROP\_AV Location: SW **Overall Compliance: No** ADA ID: 08CD49E45F64 Ramp Type: Directional1 Initial Pass/Fail: Fail **Severity Score:** 12.5

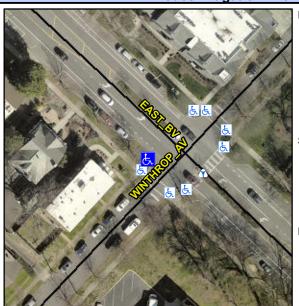
Field Measurements/Component Compliance									
Compli	Data	Compl	iance Description	Data					
N/A Ramp Length (in)		78.0	N/A Grade Break?		N/A				
Yes	Ramp Width (in)	71.0	N/A Grade Break Slope (%)		0.0				
Yes	Ramp Slope (%)	5.1	N/A Grade Break XSlope (%)		0.0				
No	Ramp XSlope (%)	5.4							
N/A	Flare Type LT	N/A	N/A	Flare Type RT	N/A				
N/A	Flare Slope LT (%)	N/A	N/A	Flare Slope RT (%)	0.0				
N/A	Flare Traversable LT?	N/A	N/A	Flare Traversable RT?	N/A				
N/A	Landing Length (in)	0.0	N/A	DWS Provided?	N/A				
N/A	Landing Width (in)	0.0	N/A	DWS Contrast?	N/A				
N/A	Landing Slope (%)	0.0	N/A	DWS Length (in)	N/A				
N/A	Landing X Slope (%)	0.0	N/A	DWS Full Width?	N/A				
N/A	Landing Curb? (Y/N)	N/A	N/A	DWS Offset LT (in)	N/A				
N/A	Shared Landing?	N/A	N/A	DWS Offset RT (in)	N/A				
N/A	Gutter Ponding?	0.0	N/A	Gutter Slope (%)	N/A				
N/A	Gutter Lip Ht (in)	0.0	N/A	Gutter X Slope (%)	N/A				
N/A	Painted X Walk1?	No		Road Slope (%)	2.4

X Walk 1 Direction	To NE		Road X Slope (%)	2.6				
	X Walk 1 Width (in)	N/A		Clear Space?	N/A				
	X Walk 1 Slope (%)	2.4	N/A	Clear Space to XWalk (in)	N/A				
	X Walk 1 X Slope (%)	2.6	N/A	Storm Grate/Utility Hazard?	N/A				
N/A	Ramp inside XWalk1?	N/A		Storm Grate/Utility Type					
N/A	Any Obstructions?	N/A			N/A				
	Obstruction Type		Yes	Surface Condition? (G/P)	Good				
		N/A	N/A	Curb Slope (%)	5.0

50	Possible Solutions:
The state of the s	Remove & Replace Entire Ramp.
A STATE OF THE PARTY OF THE PAR	Surveyor Notes:
AND THE PERSON IN	N/A
ì	PROW/ADA:
THE PERSON NAMED IN	R304.5.3

Total Cost:	\$ 1600.00
