Access Compliance Report

Public Rights-of-Way

(Curb Ramps)

Intersection ID: 10040108	Main Street: TUCKASEEGEE_RD	Cross Street: MT_CARMEL	Location: E
ADA ID: 08E1AC672B4D	Ramp Type: Directional1	Initial Pass/Fail: Fail	Overall Compliance: No
Codes/Mitigation Info/Possible Solution		Field Measurements/Component Compliance	
Severity Score: 12.5

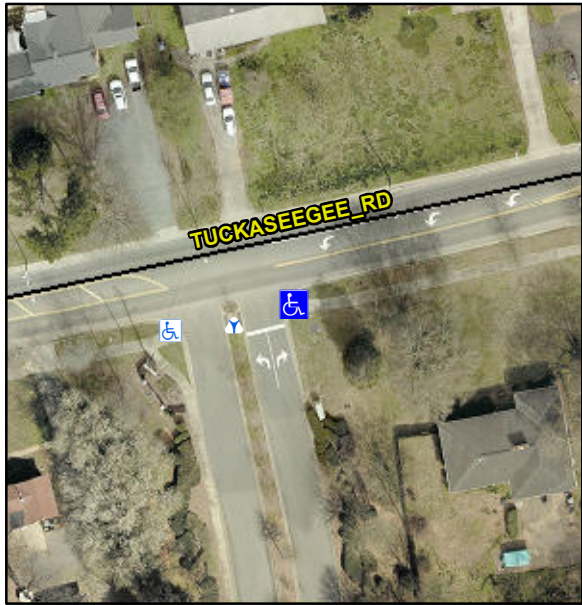
Compliance	Description	Data	Compliance	Description	Data
N/A	Ramp Length (in)	147.0	N/A	Grade Break?	N/A
Yes	Ramp Width (in)	63.0	N/A	Grade Break Slope (%)	0.0
No	Ramp Slope (%)	8.5	N/A	Grade Break XSlope (%)	0.0
Yes	Ramp XSlope (%)	0.9			
N/A	Flare Type LT	N/A	N/A	Flare Type RT	N/A
N/A	Flare Slope LT (%)	N/A	N/A	Flare Slope RT (%)	0.0
N/A	Flare Traversable LT?	N/A	N/A	Flare Traversable RT?	N/A
N/A	Landing Length (in)	0.0	N/A	DWS Provided?	N/A
N/A	Landing Width (in)	0.0	N/A	DWS Contrast?	N/A
N/A	Landing Slope (%)	0.0	N/A	DWS Length (in)	N/A
N/A	Landing X Slope (%)	0.0	N/A	DWS Full Width?	N/A
N/A	Landing Curb? (Y/N)	N/A	N/A	DWS Offset LT (in)	N/A
N/A	Shared Landing?	N/A	N/A	DWS Offset RT (in)	N/A
N/A	Gutter Ponding?	0.0	N/A	Gutter Slope (%)	N/A
N/A	Gutter Lip Ht (in)	0.0	N/A	Gutter X Slope (%)	N/A
N/A	Painted X Walk1?	No		Road Slope (%)	0.3
	X Walk 1 Direction	To W		Road X Slope (%)	4.5
	X Walk 1 Width (in)	N/A		Clear Space?	N/A

X Walk 1 Slope (%)	0.3	N/A	Clear Space to XWalk (in)	N/A
	X Walk 1 X Slope (%)	4.5	N/A	Storm Grate/Utility Hazard?	N/A
N/A	Ramp inside XWalk1?	N/A		Storm Grate/Utility Type	
N/A	Any Obstructions?	N/A			N/A
	Obstruction Type		Yes	Surface Condition? (G/P)	Good
		N/A	N/A	Curb Slope (%)	4.6

Possible Solutions:

Remove & Replace Entire Ramp.
