# Access Compliance Report

## Public Rights-of-Way

### (Curb Ramps)

Intersection ID: 3514	Main Street: OVERLOOK_MOUNTAIN_DR	Cross Street: TRANQUILLITY_DR	Location: S
ADA ID: 08E3016708A1	Ramp Type: Perp	Initial Pass/Fail: Fail	Overall Compliance: No
Severity Score: 12.5			
Codes/Mitigation Info/Possible Solution		Field Measurements/Component Compliance

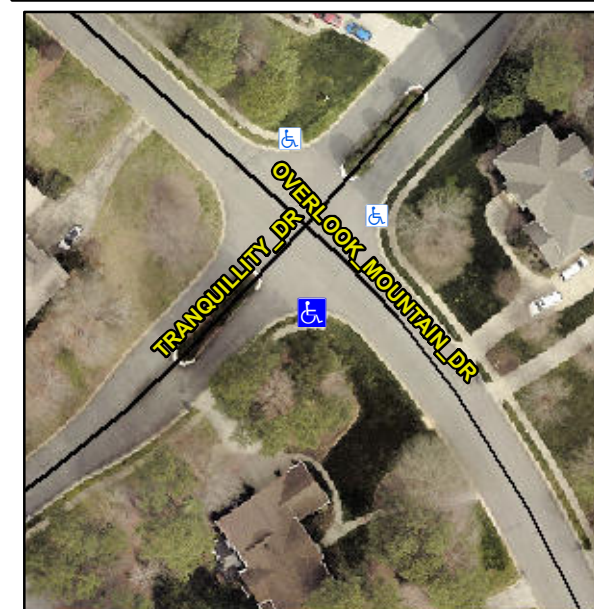
Compliance	Description	Data	Compliance	Description	Data
N/A	Ramp Length (in)	49.0	No	Ramp Slope (%)	10.1
Yes	Ramp Width (in)	48.0	Yes	Ramp XSlope (%)	0.4
N/A	Flare Type LT	N/A	N/A	Flare Type RT	N/A
N/A	Flare Slope LT (%)	N/A	N/A	Flare Slope RT (%)	N/A
N/A	Flare Traversable LT?	N/A	N/A	Flare Traversable RT?	N/A
N/A	Landing Length (in)	N/A	N/A	DWS Provided?	N/A
N/A	Landing Width (in)	N/A	N/A	DWS Contrast?	N/A
N/A	Landing Slope (%)	N/A	N/A	DWS Length (in)	N/A
N/A	Landing X Slope (%)	N/A	N/A	DWS Full Width?	N/A
N/A	Landing Curb? (Y/N)	N/A	N/A	DWS Offset (in)	N/A
N/A	Shared Landing?	N/A			
N/A	Gutter Ponding?	N/A	N/A	Gutter Slope (%)	N/A
N/A	Gutter Lip Ht (in)	N/A	N/A	Gutter X Slope (%)	N/A
N/A	Painted X Walk1?	No	N/A	Painted X Walk2?	N/A
	X Walk 1 Direction	To NE		X Walk 2 Direction	N/A
N/A	X Walk 1 Width (in)	N/A	N/A	X Walk 2 Width (in)	N/A
	X Walk 1 Slope (%)	0.3		X Walk 2 Slope (%)	N/A
	X Walk 1 X Slope (%)	0.4		X Walk 2 X Slope (%)	N/A

**Remove & Replace Entire Ramp.**

**Not Found, R304.2.2**

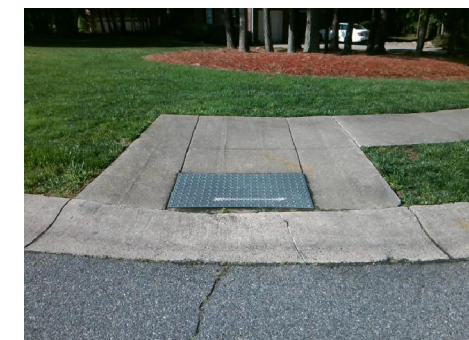
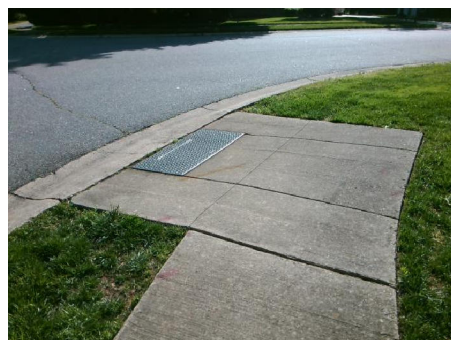
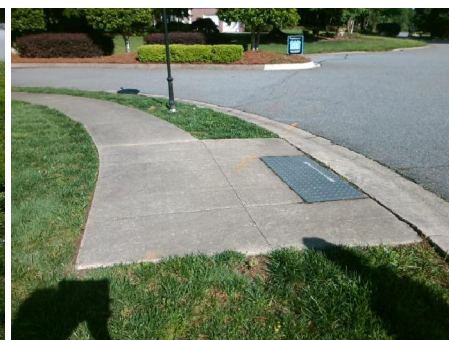
N/A	Ramp inside XWalk1?	N/A	N/A	Ramp inside XWalk2?	N/A
	Road Slope (%)	N/A	N/A	Clear Space?	N/A
	Road X Slope (%)	N/A	N/A	Clear Space to XWalk (in)	N/A
N/A	Any Obstructions?	N/A	N/A	Storm Grate/Utility Hazard?	N/A
	Obstruction Type			Storm Grate/Utility Type	
		N/A			N/A
			Yes	Surface Condition? (G/P)	Good
