Access Compliance Report

Public Rights-of-Way

(Curb Ramps)

Intersection ID: 8113	Main Street: ORR_RD	Cross Street: GRIER_RD	Location:	N
ADA ID: 08F142D79DAE	Ramp Type: Perp	Initial Pass/Fail: Fail	Overall Compliance: No	Severity Score: 26.25

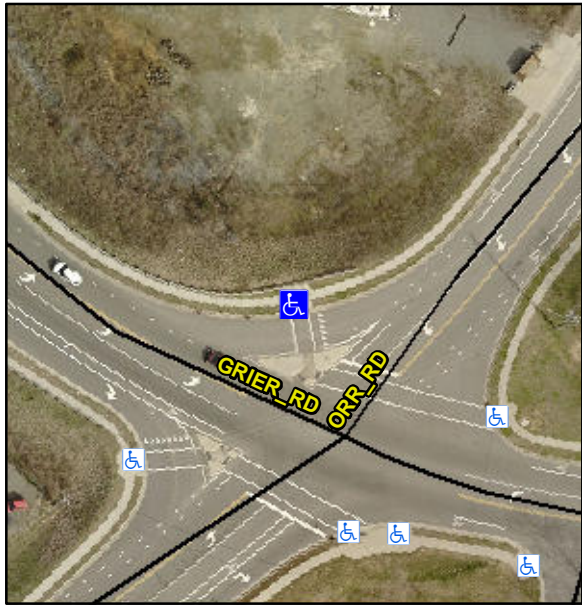
Possible Solutions:		Remove & Replace Entire Ramp.					
	Surveyor Notes:		N/A					
	PROW/ADA:		Not Found, R304.2.2, R304.5.3					
	Total Cost:		\$ 1850.00					
	Street 1 Name		ORR RD					
	Stop Condition-Street 2		YieldSign					
	Street 2 Name		N/A					
	Stop Condition-Street 1		N/A					
			Compliance	Description	Data	Compliance	Description	Data
			N/A	Ramp Length (in)	47.5	No	Ramp Slope (%)	12.3
			Yes	Ramp Width (in)	48.0	No	Ramp XSlope (%)	3.1
			N/A	Flare Type LT	N/A	N/A	Flare Type RT	N/A
			N/A	Flare Slope LT (%)	N/A	N/A	Flare Slope RT (%)	N/A
			N/A	Flare Traversable LT?	N/A	N/A	Flare Traversable RT?	N/A
			N/A	Landing Length (in)	N/A	N/A	DWS Provided?	N/A
			N/A	Landing Width (in)	N/A	N/A	DWS Contrast?	N/A
			N/A	Landing Slope (%)	N/A	N/A	DWS Length (in)	N/A
			N/A	Landing X Slope (%)	N/A	N/A	DWS Full Width?	N/A

N/A	Landing Curb? (Y/N)	N/A	N/A	DWS Offset (in)	N/A
			N/A	Shared Landing?	N/A			
			N/A	Gutter Ponding?	N/A	N/A	Gutter Slope (%)	N/A
			N/A	Gutter Lip Ht (in)	N/A	N/A	Gutter X Slope (%)	N/A
			N/A	Painted X Walk1?	Yes	N/A	Painted X Walk2?	N/A
				X Walk 1 Direction	To S		X Walk 2 Direction	N/A
			N/A	X Walk 1 Width (in)	103.5	N/A	X Walk 2 Width (in)	N/A
				X Walk 1 Slope (%)	1.8		X Walk 2 Slope (%)	N/A
				X Walk 1 X Slope (%)	3.1		X Walk 2 X Slope (%)	N/A
			N/A	Ramp inside XWalk1?	Yes	N/A	Ramp inside XWalk2?	N/A
				Road Slope (%)	N/A	N/A	Clear Space?	N/A
				Road X Slope (%)	N/A	N/A	Clear Space to XWalk (in)	N/A
			N/A	Any Obstructions?	N/A	N/A	Storm Grate/Utility Hazard?	N/A
				Obstruction Type			Storm Grate/Utility Type	
					N/A			N/A
						Yes	Surface Condition? (G/P)	Good
