# Access Compliance Report

## Public Rights-of-Way

### (Curb Ramps)

Intersection ID: 53964	Main Street: SPRING_SPRUCE_LN	Cross Street: MAGNOLIA_LILY_AV	Location: NE
ADA ID: 08F18A7D78BE	Ramp Type: Perp	Initial Pass/Fail: Fail	Overall Compliance: No
Severity Score: 22.5			
Codes/Mitigation Info/Possible Solution		Field Measurements/Component Compliance

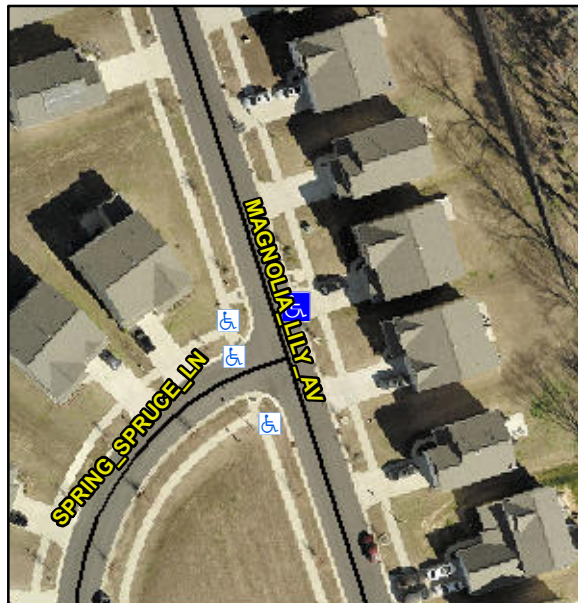
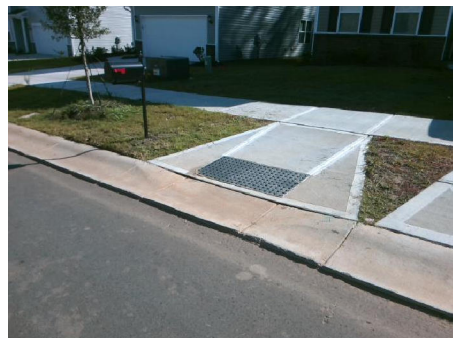
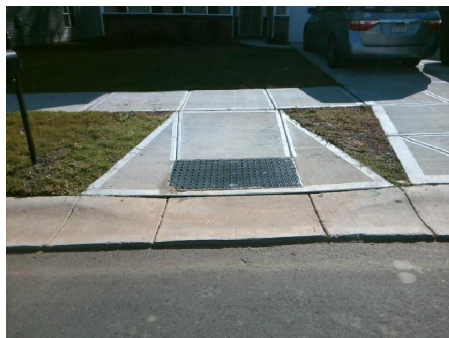
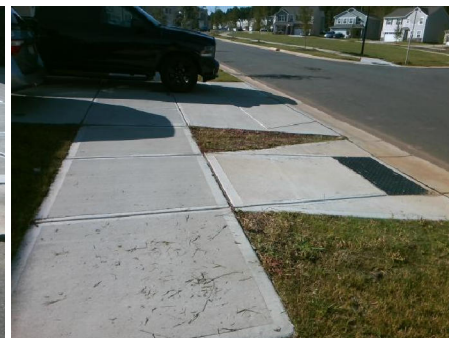
**Not Found, R304.5.1, R304.2.2, R304.5.3**

Compliance	Description	Data	Compliance	Description	Data
N/A	Ramp Length (in)	94.5	No	Ramp Slope (%)	8.4
No	Ramp Width (in)	47.0	No	Ramp XSlope (%)	4.1
N/A	Flare Type LT	N/A	N/A	Flare Type RT	N/A
N/A	Flare Slope LT (%)	N/A	N/A	Flare Slope RT (%)	N/A
N/A	Flare Traversable LT?	N/A	N/A	Flare Traversable RT?	N/A
N/A	Landing Length (in)	N/A	N/A	DWS Provided?	N/A
N/A	Landing Width (in)	N/A	N/A	DWS Contrast?	N/A
N/A	Landing Slope (%)	N/A	N/A	DWS Length (in)	N/A
N/A	Landing X Slope (%)	N/A	N/A	DWS Full Width?	N/A
N/A	Landing Curb? (Y/N)	N/A	N/A	DWS Offset (in)	N/A
N/A	Shared Landing?	N/A			
N/A	Gutter Ponding?	N/A	N/A	Gutter Slope (%)	N/A
N/A	Gutter Lip Ht (in)	1.0	N/A	Gutter X Slope (%)	N/A
N/A	Painted X Walk1?	No	N/A	Painted X Walk2?	N/A
	X Walk 1 Direction	To W		X Walk 2 Direction	N/A
N/A	X Walk 1 Width (in)	N/A	N/A	X Walk 2 Width (in)	N/A
	X Walk 1 Slope (%)	3.5		X Walk 2 Slope (%)	N/A
	X Walk 1 X Slope (%)	3.9		X Walk 2 X Slope (%)	N/A

N/A	Ramp inside XWalk1?	N/A	N/A	Ramp inside XWalk2?	N/A
	Road Slope (%)	N/A	N/A	Clear Space?	N/A
	Road X Slope (%)	N/A	N/A	Clear Space to XWalk (in)	N/A
N/A	Any Obstructions?	N/A	N/A	Storm Grate/Utility Hazard?	N/A
	Obstruction Type			Storm Grate/Utility Type	
		N/A			N/A
			Yes	Surface Condition? (G/P)	Good

**Remove & Replace Entire Ramp.**

Total Cost: \$ 1850.00
