Access Compliance Report

Public Rights-of-Way

(Curb Ramps)

Intersection ID: 29157	Main Street: STONEY_GARDEN_DR	Cross Street: WALLACE_RIDGE_DR	Location: NW
ADA ID: 09050487E94B	Ramp Type: PerpDiag	Initial Pass/Fail: Fail	Overall Compliance: No
Severity Score: 33.75			
Codes/Mitigation Info/Possible Solution		Field Measurements/Component Compliance

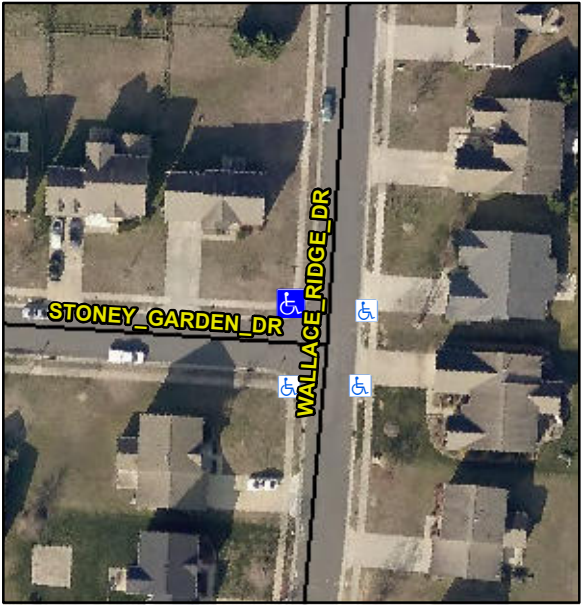
Possible Solutions:		Compliance		Description		Data	Compliance	Description	Data
	Remove & Replace Curb Ramp With Two New Directional Ramps or Equivalent.		N/A		Ramp Length (in)		50.0	Yes	Ramp Slope (%)	7.1
<p>Surveyor Notes:</p> <p>N/A</p>			No		Ramp Width (in)		46.0	No	Ramp XSlope (%)	7.8
			N/A		Flare Type LT		N/A	N/A	Flare Type RT	N/A
<p>PROW/ADA:</p> <p>R304.5.1, R304.5.3</p>			N/A		Flare Slope LT (%)		N/A	N/A	Flare Slope RT (%)	N/A
			N/A		Flare Traversable LT?		N/A	N/A	Flare Traversable RT?	N/A
<p>Total Cost:</p> <p>\$ 3200.00</p>			N/A		Landing Length (in)		N/A	N/A	DWS Provided?	N/A
			N/A		Landing Width (in)		N/A	N/A	DWS Contrast?	N/A
			N/A		Landing Slope (%)		N/A	N/A	DWS Length (in)	N/A
			N/A		Landing X Slope (%)		N/A	N/A	DWS Full Width?	N/A
			N/A		Landing Curb? (Y/N)		N/A	N/A	DWS Offset (in)	N/A
			N/A		Shared Landing?		N/A			
			N/A		Gutter Ponding?		N/A	N/A	Gutter Slope (%)	N/A
			N/A		Gutter Lip Ht (in)		N/A	N/A	Gutter X Slope (%)	N/A

N/A		Painted X Walk1?		No	N/A	Painted X Walk2?	No
					X Walk 1 Direction		To S		X Walk 2 Direction	To E
			N/A		X Walk 1 Width (in)		N/A	N/A	X Walk 2 Width (in)	N/A
					X Walk 1 Slope (%)		1.8		X Walk 2 Slope (%)	1.6
					X Walk 1 X Slope (%)		0.6		X Walk 2 X Slope (%)	2.7
			N/A		Ramp inside XWalk1?		N/A	N/A	Ramp inside XWalk2?	N/A
					Road Slope (%)		4.3	N/A	Clear Space?	N/A
					Road X Slope (%)		2.2	N/A	Clear Space to XWalk (in)	N/A
			N/A		Any Obstructions?		N/A	N/A	Storm Grate/Utility Hazard?	N/A
					Obstruction Type				Storm Grate/Utility Type	
								N/A		N/A
								Yes	Surface Condition? (G/P)	Good
