| Intersection ID: 4819 | Main Street: CLIFF_CAMERON_DR | Cross Street: WILLIAM_FICKLEN_DR | Location: | NE |
| ADA ID: 091AA75D0E12 | Ramp Type: Perp | Initial Pass/Fail: Fail | Overall Compliance: No | Severity Score: 10 |

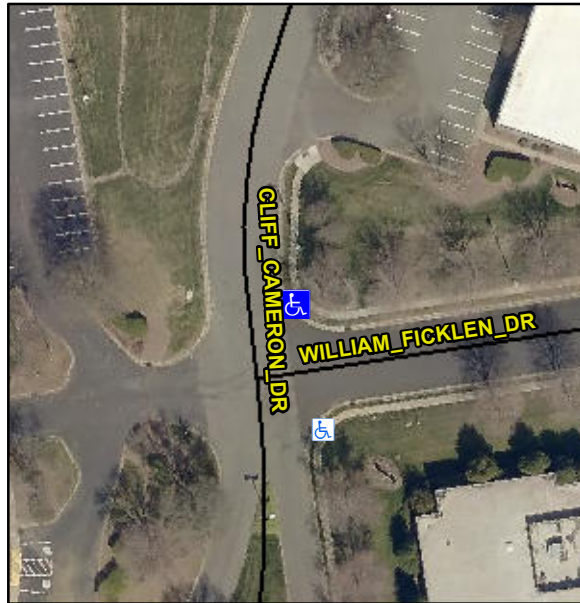
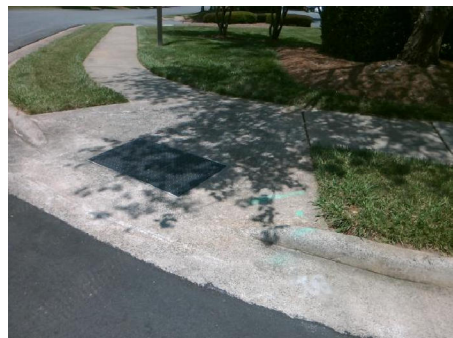
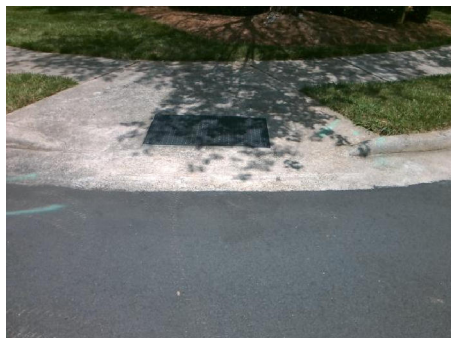
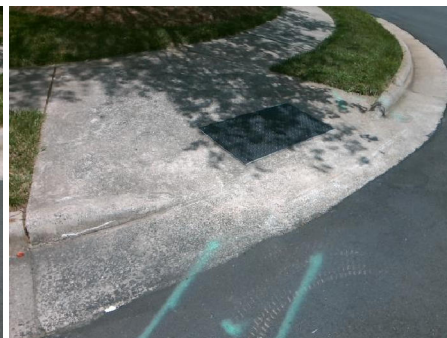
### R304.5.1, R304.5.3

| Compliance | Description | Data | Compliance | Description | Data |
|---|---|---|---|---|---|
| No | Ramp Width (in) | 46.0 | No | Ramp XSlope (%) | 4.7 |

### Remove & Replace Entire Ramp.

Total Cost: \$ 1850.00
