Access Compliance Report Public Rights-of-Way (Curb Ramps)

Intersection ID: N/A Main Str	Main Street: CANTERBURY_CASTLE_DR			Cross Street: BELVEDERE_CASTLE_DR			
ADA ID: 0925CB8CDA10 Ramp Ty	B8CDA10 Ramp Type: Perp			Initial Pass/Fail: Fail Overall Compliance: N			10
Codes/Mitigation Info/Possible Solution		Field Measurements/Component Compliance					
	Possible Solutions:	Comp	Compliance Description		Data Compliance Description		Data
	Remove & Replace Entire Ramp	N/A	Ramp Length (in)	98.0	Yes	Ramp Slope (%)	7.3
		No	Ramp Width (in)	47.0	No	Ramp XSlope (%)	3.6
		N/A	Flare Type LT	N/A	N/A	Flare Type RT	N/A
		N/A	Flare Slope LT (%)	N/A	N/A	Flare Slope RT (%)	N/A
		N/A	Flare Traversable LT?	N/A	N/A	Flare Traversable RT?	N/A
the second se		N/A	Landing Length (in)	N/A	N/A	DWS Provided?	N/A
E.S. Cat	Surveyor Notes:	N/A	Landing Width (in)	N/A	N/A	DWS Contrast?	N/A
the second second	N/A	N/A	Landing Slope (%)	N/A	N/A	DWS Length (in)	N/A
A CARACTER AND A CARACTER		N/A	Landing X Slope (%)	N/A	N/A	DWS Full Width?	N/A

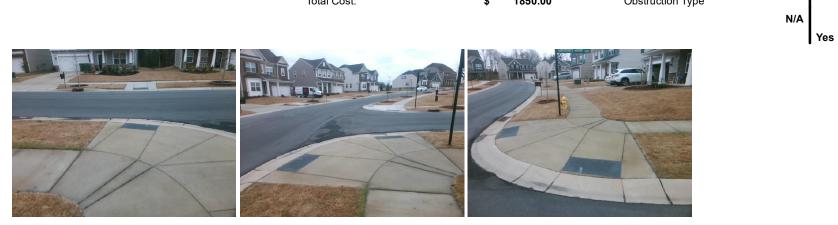
Sal And		N/A	Landing Curb? (Y/N)	N/A	N/A	DWS Offset (in)	N/A
	-	N/A	Shared Landing?	N/A			
	PROW/ADA:	N/A	Gutter Ponding?	N/A	N/A	Gutter Slope (%)	N/A
	Not Found, R304.5.1, R304.5.3	N/A	Gutter Lip Ht (in)	N/A	N/A	Gutter X Slope (%)	N/A
1 he we and the		N/A	Painted X Walk1?	No	N/A	Painted X Walk2?	N/A
the second states			X Walk 1 Direction	To NW		X Walk 2 Direction	N/A
the stand of the stand		N/A	X Walk 1 Width (in)	N/A	N/A	X Walk 2 Width (in)	N/A
Street 1 Name CANTERBURY CASTLE DR			X Walk 1 Slope (%)	3.6		X Walk 2 Slope (%)	N/A
Stop Condition-Street 2 None			X Walk 1 X Slope (%)	1.3		X Walk 2 X Slope (%)	N/A
Street 2 Name N/A		N/A	Ramp inside XWalk1?	N/A	N/A	Ramp inside XWalk2?	N/A
Stop Condition-Street 1 N/A			Road Slope (%)	N/A	N/A	Clear Space?	N/A
			Road X Slope (%)	N/A	N/A	Clear Space to XWalk (in)	N/A
		N/A	Any Obstructions?	N/A	N/A	Storm Grate/Utility Hazard?	N/A
	Total Cost: \$ 1	850.00	Obstruction Type			Storm Grate/Utility Type
