Access Compliance Report

Public Rights-of-Way

(Curb Ramps)

Intersection ID: 16396	Main Street: WENDOVER_RD	Cross Street: BEAL_ST	Location: SE
ADA ID: 093FAD0BD0B1	Ramp Type: Perp	Initial Pass/Fail: Fail	Overall Compliance: No
Severity Score: 22.5			
Codes/Mitigation Info/Possible Solution		Field Measurements/Component Compliance

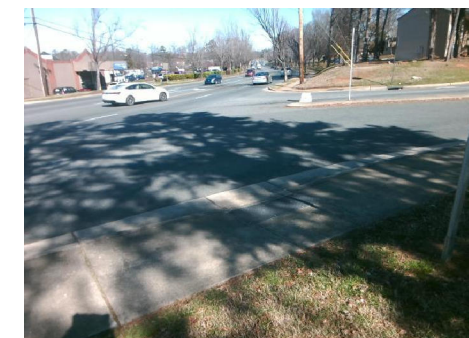
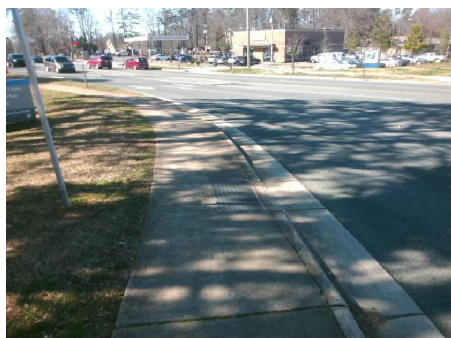
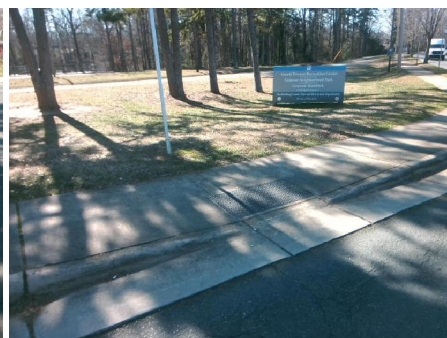
Not Found, R304.5.1, R304.2.2, R304.5.3

Compliance	Description	Data	Compliance	Description	Data
N/A	Ramp Length (in)	60.0	No	Ramp Slope (%)	11.5
No	Ramp Width (in)	44.0	No	Ramp XSlope (%)	3.5
N/A	Flare Type LT	N/A	N/A	Flare Type RT	N/A
N/A	Flare Slope LT (%)	N/A	N/A	Flare Slope RT (%)	N/A
N/A	Flare Traversable LT?	N/A	N/A	Flare Traversable RT?	N/A
N/A	Landing Length (in)	N/A	N/A	DWS Provided?	N/A
N/A	Landing Width (in)	N/A	N/A	DWS Contrast?	N/A
N/A	Landing Slope (%)	N/A	N/A	DWS Length (in)	N/A
N/A	Landing X Slope (%)	N/A	N/A	DWS Full Width?	N/A
N/A	Landing Curb? (Y/N)	N/A	N/A	DWS Offset (in)	N/A
N/A	Shared Landing?	N/A			
N/A	Gutter Ponding?	N/A	N/A	Gutter Slope (%)	N/A
N/A	Gutter Lip Ht (in)	N/A	N/A	Gutter X Slope (%)	N/A
N/A	Painted X Walk1?	No	N/A	Painted X Walk2?	N/A
	X Walk 1 Direction	To NE		X Walk 2 Direction	N/A
N/A	X Walk 1 Width (in)	N/A	N/A	X Walk 2 Width (in)	N/A
	X Walk 1 Slope (%)	0.7		X Walk 2 Slope (%)	N/A
	X Walk 1 X Slope (%)	5.8		X Walk 2 X Slope (%)	N/A

N/A	Ramp inside XWalk1?	N/A	N/A	Ramp inside XWalk2?	N/A
	Road Slope (%)	N/A	N/A	Clear Space?	N/A
	Road X Slope (%)	N/A	N/A	Clear Space to XWalk (in)	N/A
N/A	Any Obstructions?	N/A	N/A	Storm Grate/Utility Hazard?	N/A
	Obstruction Type			Storm Grate/Utility Type	
		N/A			N/A
			Yes	Surface Condition? (G/P)	Good

Remove & Replace Entire Ramp.
