# Access Compliance Report

## Public Rights-of-Way

Intersection ID: 25211	Main Street: SMITH_RD	Cross Street: SOUTHBRIDGE_FOREST_DR	Location: NE
ADA ID: 0946FA68D8E3	Ramp Type: Perp	Initial Pass/Fail: Fail	Overall Compliance: No
		Severity Score: 12.5

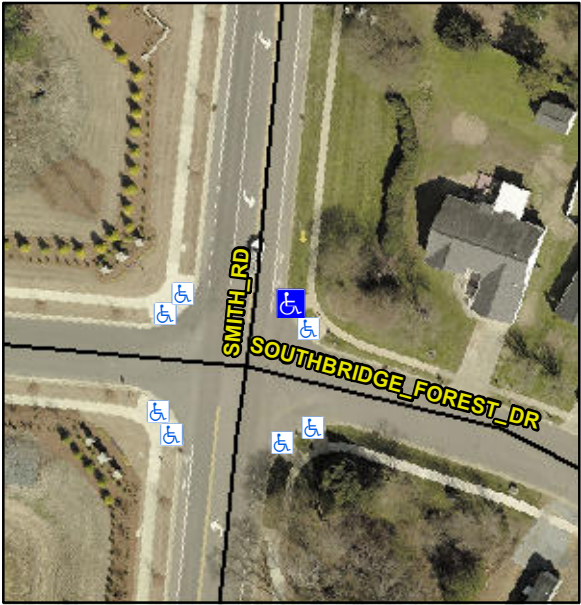
Compliance	Description	Data	Compliance	Description	Data
N/A	Ramp Length (in)	120.0	No	Ramp Slope (%)	10.8
Yes	Ramp Width (in)	89.0	Yes	Ramp XSlope (%)	0.4
N/A	Flare Type LT	N/A	N/A	Flare Type RT	N/A
N/A	Flare Slope LT (%)	N/A	N/A	Flare Slope RT (%)	N/A
N/A	Flare Traversable LT?	N/A	N/A	Flare Traversable RT?	N/A
N/A	Landing Length (in)	N/A	N/A	DWS Provided?	N/A
N/A	Landing Width (in)	N/A	N/A	DWS Contrast?	N/A
N/A	Landing Slope (%)	N/A	N/A	DWS Length (in)	N/A
N/A	Landing X Slope (%)	N/A	N/A	DWS Full Width?	N/A
N/A	Landing Curb? (Y/N)	N/A	N/A	DWS Offset (in)	N/A
N/A	Shared Landing?	N/A			
N/A	Gutter Ponding?	N/A	N/A	Gutter Slope (%)	N/A
N/A	Gutter Lip Ht (in)	N/A	N/A	Gutter X Slope (%)	N/A
N/A	Painted X Walk1?	No	N/A	Painted X Walk2?	N/A
	X Walk 1 Direction	To NW		X Walk 2 Direction	N/A
N/A	X Walk 1 Width (in)	N/A	N/A	X Walk 2 Width (in)	N/A
	X Walk 1 Slope (%)	4.3		X Walk 2 Slope (%)	N/A
	X Walk 1 X Slope (%)	1.7		X Walk 2 X Slope (%)	N/A

N/A	Ramp inside XWalk1?	N/A	N/A	Ramp inside XWalk2?	N/A
	Road Slope (%)	N/A	N/A	Clear Space?	N/A
	Road X Slope (%)	N/A	N/A	Clear Space to XWalk (in)	N/A
N/A	Any Obstructions?	N/A	N/A	Storm Grate/Utility Hazard?	N/A
	Obstruction Type			Storm Grate/Utility Type	
		N/A			N/A
			Yes	Surface Condition? (G/P)	Good

Possible Solutions:				
	Remove & Replace Entire Ramp.				
	Surveyor Notes:				
	N/A				
	PROW/ADA:				
	Not Found, R304.2.2				
Street 1 Name	SMITH RD				
Stop Condition-Street 2	None				
Street 2 Name	N/A				
Stop Condition-Street 1	N/A				
Total Cost:		\$	1850.00
