Access Compliance Report

Public Rights-of-Way

(Curb Ramps)

Intersection ID: 52476	Main Street: WHITEHALL_EXECUTIVE_CENTER_DR	Cross Street: N/A	Location: NE
ADA ID: 09476B937BB0	Ramp Type: Perp	Initial Pass/Fail: Fail	Overall Compliance: No
Codes/Mitigation Info/Possible Solution		Field Measurements/Component Compliance	
Severity Score: 13.75

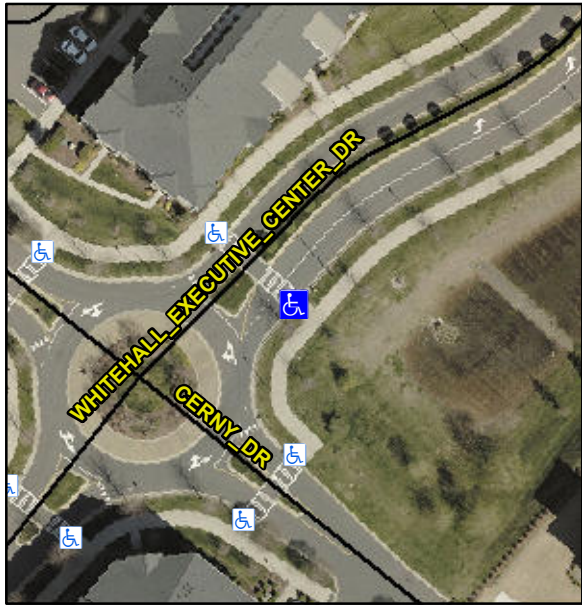
Not Found, R304.2.2, R304.5.3

Compliance	Description	Data	Compliance	Description	Data
N/A	Ramp Length (in)	93.0	No	Ramp Slope (%)	9.6
Yes	Ramp Width (in)	94.0	No	Ramp XSlope (%)	4.5
N/A	Flare Type LT	N/A	N/A	Flare Type RT	N/A
N/A	Flare Slope LT (%)	N/A	N/A	Flare Slope RT (%)	N/A
N/A	Flare Traversable LT?	N/A	N/A	Flare Traversable RT?	N/A
N/A	Landing Length (in)	N/A	N/A	DWS Provided?	N/A
N/A	Landing Width (in)	N/A	N/A	DWS Contrast?	N/A
N/A	Landing Slope (%)	N/A	N/A	DWS Length (in)	N/A
N/A	Landing X Slope (%)	N/A	N/A	DWS Full Width?	N/A
N/A	Landing Curb? (Y/N)	N/A	N/A	DWS Offset (in)	N/A
N/A	Shared Landing?	N/A			
N/A	Gutter Ponding?	N/A	N/A	Gutter Slope (%)	N/A
N/A	Gutter Lip Ht (in)	N/A	N/A	Gutter X Slope (%)	N/A
N/A	Painted X Walk1?	Yes	N/A	Painted X Walk2?	N/A
	X Walk 1 Direction	To NW		X Walk 2 Direction	N/A
N/A	X Walk 1 Width (in)	113.0	N/A	X Walk 2 Width (in)	N/A
	X Walk 1 Slope (%)	3.3		X Walk 2 Slope (%)	N/A
	X Walk 1 X Slope (%)	3.2		X Walk 2 X Slope (%)	N/A

N/A	Ramp inside XWalk1?	Yes	N/A	Ramp inside XWalk2?	N/A
	Road Slope (%)	N/A	N/A	Clear Space?	N/A
	Road X Slope (%)	N/A	N/A	Clear Space to XWalk (in)	N/A
N/A	Any Obstructions?	N/A	N/A	Storm Grate/Utility Hazard?	N/A
	Obstruction Type			Storm Grate/Utility Type	
		N/A			N/A
		Yes		Surface Condition? (G/P)	Good

Possible Solutions:

Remove & Replace Entire Ramp.
