Access Compliance Report

Public Rights-of-Way

(Curb Ramps)

Intersection ID: 27962	Main Street: PINE_VALLEY_CLUB_DR	Cross Street: ROYAL_ABERDEEN_CT	Location: NE
ADA ID: 094CCB35125D	Ramp Type: Perp	Initial Pass/Fail: Fail	Overall Compliance: No
Codes/Mitigation Info/Possible Solution		Field Measurements/Component Compliance	
Severity Score: 13.75

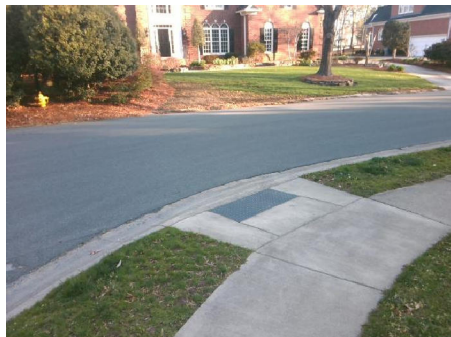
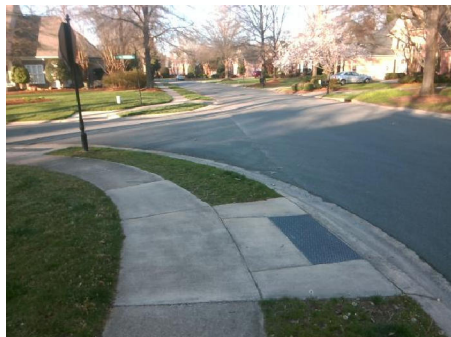
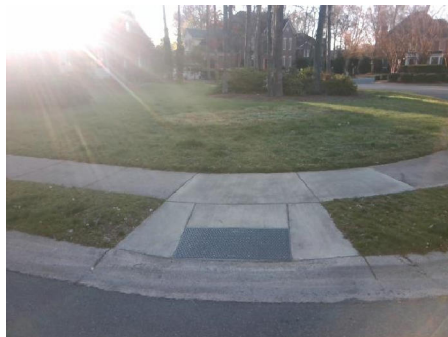
Not Found, R304.2.2, R304.5.3

Compliance	Description	Data	Compliance	Description	Data
N/A	Ramp Length (in)	49.0	No	Ramp Slope (%)	10.6
Yes	Ramp Width (in)	48.0	No	Ramp XSlope (%)	2.2
N/A	Flare Type LT	N/A	N/A	Flare Type RT	N/A
N/A	Flare Slope LT (%)	N/A	N/A	Flare Slope RT (%)	N/A
N/A	Flare Traversable LT?	N/A	N/A	Flare Traversable RT?	N/A
N/A	Landing Length (in)	N/A	N/A	DWS Provided?	N/A
N/A	Landing Width (in)	N/A	N/A	DWS Contrast?	N/A
N/A	Landing Slope (%)	N/A	N/A	DWS Length (in)	N/A
N/A	Landing X Slope (%)	N/A	N/A	DWS Full Width?	N/A
N/A	Landing Curb? (Y/N)	N/A	N/A	DWS Offset (in)	N/A
N/A	Shared Landing?	N/A			
N/A	Gutter Ponding?	N/A	N/A	Gutter Slope (%)	N/A
N/A	Gutter Lip Ht (in)	N/A	N/A	Gutter X Slope (%)	N/A
N/A	Painted X Walk1?	No	N/A	Painted X Walk2?	N/A
	X Walk 1 Direction	To NW		X Walk 2 Direction	N/A
N/A	X Walk 1 Width (in)	N/A	N/A	X Walk 2 Width (in)	N/A
	X Walk 1 Slope (%)	3.5		X Walk 2 Slope (%)	N/A
	X Walk 1 X Slope (%)	1.5		X Walk 2 X Slope (%)	N/A

N/A	Ramp inside XWalk1?	N/A	N/A	Ramp inside XWalk2?	N/A
	Road Slope (%)	1.5	N/A	Clear Space?	N/A
	Road X Slope (%)	3.5	N/A	Clear Space to XWalk (in)	N/A
N/A	Any Obstructions?	N/A	N/A	Storm Grate/Utility Hazard?	N/A
	Obstruction Type			Storm Grate/Utility Type	
		N/A			N/A
			Yes	Surface Condition? (G/P)	Good

Remove & Replace Entire Ramp.
