# Access Compliance Report

## Public Rights-of-Way

### (Curb Ramps)

Intersection ID: 13981	Main Street: NORWICH_PL	Cross Street: WALTON_RD	Location: SE
ADA ID: 095D29FF0F0B	Ramp Type: Directional1	Initial Pass/Fail: Fail	Overall Compliance: No
Codes/Mitigation Info/Possible Solution		Field Measurements/Component Compliance	
Severity Score: 1.25

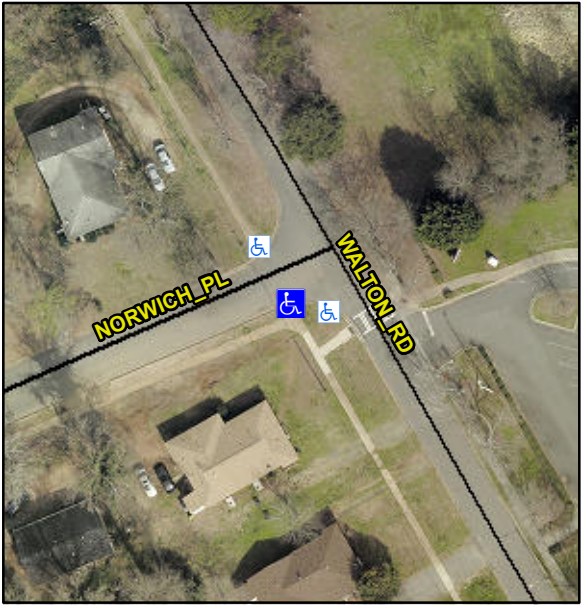
Compliance	Description	Data	Compliance	Description	Data
N/A	Ramp Length (in)	51.0	N/A	Grade Break?	N/A
Yes	Ramp Width (in)	48.0	N/A	Grade Break Slope (%)	0.0
Yes	Ramp Slope (%)	4.4	N/A	Grade Break XSlope (%)	0.0
No	Ramp XSlope (%)	2.1			
N/A	Flare Type LT	N/A	N/A	Flare Type RT	N/A
N/A	Flare Slope LT (%)	N/A	N/A	Flare Slope RT (%)	0.0
N/A	Flare Traversable LT?	N/A	N/A	Flare Traversable RT?	N/A
N/A	Landing Length (in)	0.0	N/A	DWS Provided?	N/A
N/A	Landing Width (in)	0.0	N/A	DWS Contrast?	N/A
N/A	Landing Slope (%)	0.0	N/A	DWS Length (in)	N/A
N/A	Landing X Slope (%)	0.0	N/A	DWS Full Width?	N/A
N/A	Landing Curb? (Y/N)	N/A	N/A	DWS Offset LT (in)	N/A
N/A	Shared Landing?	N/A	N/A	DWS Offset RT (in)	N/A
N/A	Gutter Ponding?	0.0	N/A	Gutter Slope (%)	N/A
N/A	Gutter Lip Ht (in)	0.0	N/A	Gutter X Slope (%)	N/A
N/A	Painted X Walk1?	No		Road Slope (%)	2.3
	X Walk 1 Direction	To NW		Road X Slope (%)	1.1
	X Walk 1 Width (in)	N/A		Clear Space?	N/A

X Walk 1 Slope (%)	2.3	N/A	Clear Space to XWalk (in)	N/A
	X Walk 1 X Slope (%)	1.1	N/A	Storm Grate/Utility Hazard?	N/A
N/A	Ramp inside XWalk1?	N/A		Storm Grate/Utility Type	
N/A	Any Obstructions?	N/A			N/A
	Obstruction Type		Yes	Surface Condition? (G/P)	Good
			N/A	Curb Slope (%)	10.5

Possible Solutions:			
	Remove & Replace Entire Ramp.			
<p>Surveyor Notes:</p> <p>N/A</p>	PROW/ADA:			
	R304.5.3			
Street 1 Name	NORWICH PL			
Stop Condition-Street 1	StopSign			
Street 2 Name	N/A			
Stop Condition-Street 2	N/A			
Total Cost:		\$	1600.00
