Access Compliance Report

Public Rights-of-Way

(Curb Ramps)

Intersection ID: 46739	Main Street: BOBHOUSE_DR	Cross Street: BEAVER_BROOK_WY	Location: SE
ADA ID: 096C2D5DBF37	Ramp Type: PerpDiag	Initial Pass/Fail: Fail	Overall Compliance: No
		Severity Score: 10

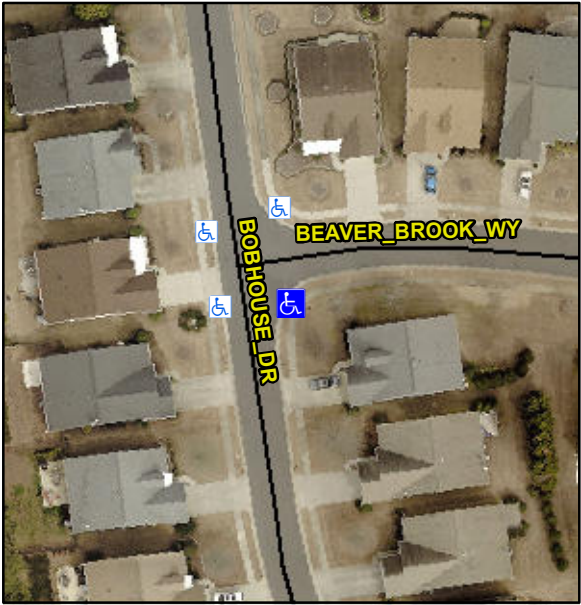
<p>Street 1 Name BOBHOUSE DR</p> <p>Stop Condition-Street 2 None</p> <p>Street 2 Name BEAVER BROOK WY</p> <p>Stop Condition-Street 1 StopSign</p>	Possible Solutions:		Compliance	Description	Data
	Remove & Replace Curb Ramp With Two New Directional Ramps or Equivalent.		Yes	Ramp Slope (%)	7.9
			No	Ramp Width (in)	3.2
			N/A	Flare Type LT	N/A
			N/A	Flare Slope LT (%)	N/A
			N/A	Flare Traversable LT?	N/A
			N/A	Landing Length (in)	N/A
			N/A	Landing Width (in)	N/A
			N/A	Landing Slope (%)	N/A
			N/A	Landing X Slope (%)	N/A
			N/A	Landing Curb? (Y/N)	N/A
			N/A	Shared Landing?	N/A
			N/A	Gutter Ponding?	N/A
			N/A	Gutter Lip Ht (in)	N/A
			No	Painted X Walk1?	No
			To N	X Walk 2 Direction	To W
			N/A	X Walk 1 Width (in)	N/A

1.1	X Walk 1 Slope (%)	4.6
			3.7	X Walk 1 X Slope (%)	2.1
			N/A	Ramp inside XWalk1?	N/A
<p>Surveyor Notes:</p> <p>N/A</p> <p>PROW/ADA:</p> <p>Not Found, R304.5.1, R304.5.3</p> <p>Total Cost: \$ 3200.00</p>			N/A	Ramp inside XWalk2?	N/A

3.4	Road Slope (%)	N/A
			3.3	Road X Slope (%)	N/A
			N/A	Any Obstructions?	N/A
				Obstruction Type	
			N/A	Storm Grate/Utility Hazard?	N/A
				Storm Grate/Utility Type	
			N/A		N/A
			Yes	Surface Condition? (G/P)	Good
