# Access Compliance Report

## Public Rights-of-Way

### (Curb Ramps)

Intersection ID: 5025	Main Street: CLARENCEFIELD_DR	Cross Street: PENNYCROSS_LN	Location: SW
ADA ID: 0971869227CC	Ramp Type: Combination1	Initial Pass/Fail: Fail	Overall Compliance: No
			Severity Score: 21.25

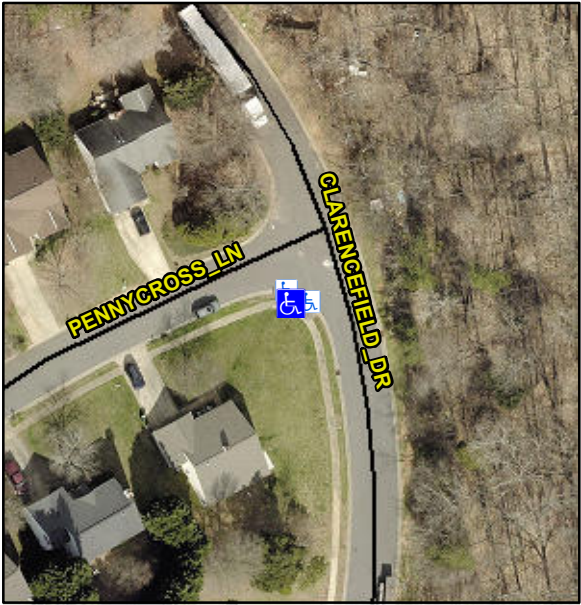
Possible Solutions:			<b>Compliance</b>	<b>Description</b>	<b>Data</b>	
	<b>Remove &amp; Replace Entire Ramp.</b>			N/A	Ramp Length LT (in)	20.0	N/A
				No	Ramp Width LT (in)	46.0	No
				Yes	Ramp Slope LT (%)	5.6	Yes
				No	Ramp XSlope LT (%)	3.8	No
				N/A	Ramp Length (in)	54.0	Yes
				Yes	Ramp Width (in)	48.0	No
				N/A	Flare Type LT	N/A	N/A
				N/A	Flare Slope LT (%)	N/A	N/A
				N/A	Flare Traversable LT?	N/A	N/A
<p>Surveyor Notes:</p> <p><b>RP &lt; 5%</b></p> <p>PROW/ADA:</p> <p><b>Not Found, R304.5.1, R304.5.3</b></p>				N/A	Ramp Length RT (in)	64.0	N/A
				No	Ramp Width RT (in)	47.5	No
				Yes	Ramp Slope RT (%)	6.4	Yes
				No	Ramp XSlope RT (%)	2.8	No
				Yes	Ramp Slope (%)	3.5	No
				No	Ramp XSlope (%)	6.6	N/A
				N/A	Flare Type RT	N/A	N/A
				N/A	Flare Slope RT (%)	N/A	N/A
				N/A	Flare Traversable RT?	N/A	N/A
				N/A	DWS Provided?	N/A	N/A

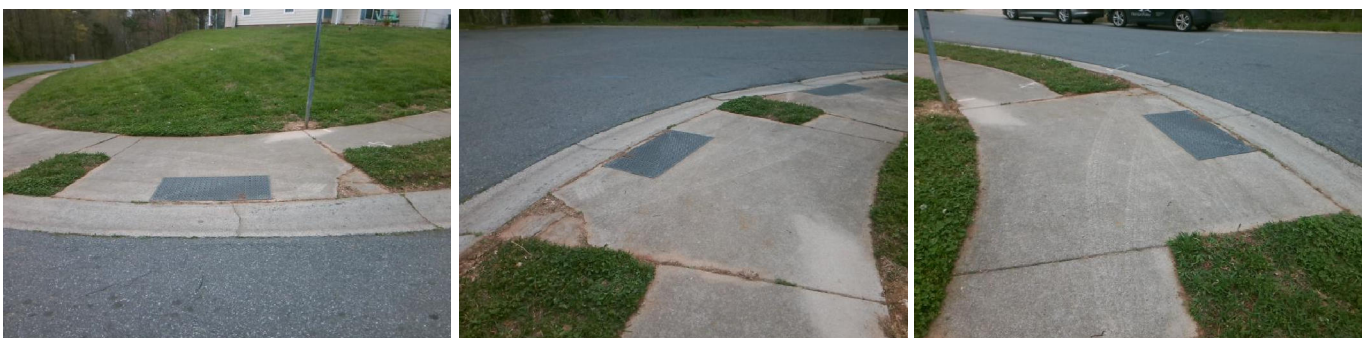
<p>Street 1 Name</p> <p>Stop Condition-Street 1</p> <p>Street 2 Name</p> <p>Stop Condition-Street 2</p>				N/A	DWS Contrast?	N/A	N/A
				N/A	DWS Length (in)	N/A	N/A
				N/A	DWS Full Width?	N/A	N/A
				N/A	DWS Offset (in)	N/A	N/A
				N/A	Gutter Slope (%)	N/A	N/A
				N/A	Gutter Lip Ht (in)	N/A	N/A
				N/A	Gutter X Slope (%)	N/A	N/A
				N/A	Painted X Walk1?	No	N/A
				N/A	Painted X Walk2?	N/A	N/A
				N/A	X Walk 1 Direction	To N	N/A
<p>Total Cost:</p> <p><b>\$ 1800.00</b></p>				N/A	X Walk 2 Direction	N/A	N/A
				N/A	X Walk 1 Width (in)	N/A	N/A
				N/A	X Walk 2 Width (in)	N/A	N/A
				N/A	X Walk 1 Slope (%)	0.1	N/A
				N/A	X Walk 2 Slope (%)	N/A	N/A
				N/A	X Walk 1 X Slope (%)	4.3	N/A
				N/A	X Walk 2 X Slope (%)	N/A	N/A
				N/A	Ramp inside XWalk1?	N/A	N/A
				N/A	Ramp inside XWalk2?	N/A	N/A
				N/A	Road Slope (%)	4.3	N/A
