Access Compliance Report

Public Rights-of-Way

(Curb Ramps)

| Intersection ID: 13692 | Main Street: N_TORRENCE_ST | Cross Street: E_5TH_ST | Location: | N |

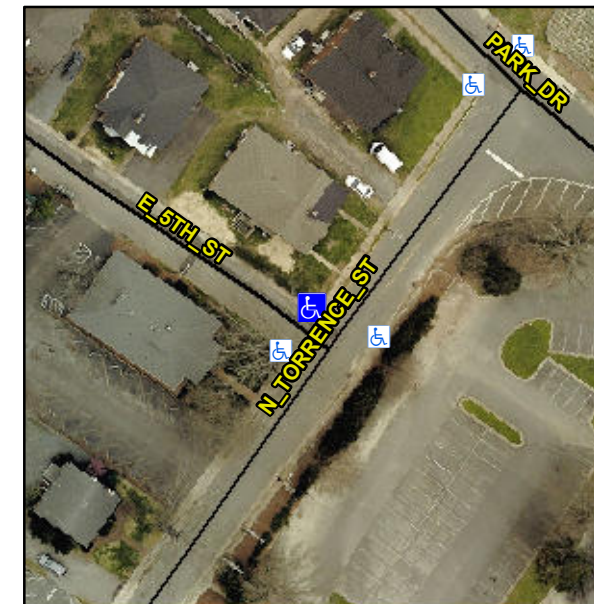
| ADA ID: 097D0EA46C91 | Ramp Type: PerpDiag | Initial Pass/Fail: Fail | Overall Compliance: No | Severity Score: 12.5 |

Not Found, R304.2.2

| Compliance | Description | Data | Compliance | Description | Data |
|---|---|---|---|---|---|
| N/A | Ramp Length (in) | 48.0 | No | Ramp Slope (%) | 8.5 |
| N/A | Gutter Ponding? | Yes | N/A | Gutter Slope (%) | N/A |

Remove & Replace Curb Ramp With Two New Directional Ramps or Equivalent.
