## Access Compliance Report Public Rights-of-Way (Curb Ramps)

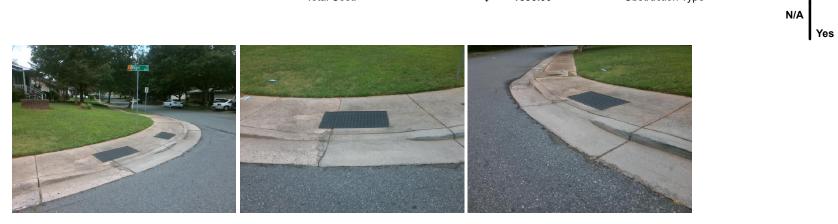
Intersection ID: 10144	Main Street: FONTANA_AV			Street:	VOGEL_CT	Location:	NE			
ADA ID: 097FAE86719B	Ramp Type: Perp			Initial Pass/Fail: Fail Overall Compliance: No				o Severity Score:	1.25	
Codes/Mitigation Info/Possible Solution				Field Measurements/Component Compliance						
		Possible Solutions:		Compliance Description Data Complia			liance Description	Data		
1 1 1 1 1 1 1 1	x P/	Remove & Replace Entire Ramp		N/A	Ramp Length (in)	59.0	Yes	Ramp Slope (%)	7.1	
State And And	A Wal	1		Yes	Ramp Width (in)	48.0	No	Ramp XSlope (%)	3.9	
R R	12			N/A	Flare Type LT	N/A	N/A	Flare Type RT	N/A	
	1 Sa			N/A	Flare Slope LT (%)	N/A	N/A	Flare Slope RT (%)	N/A	
	A PAR			N/A	Flare Traversable LT?	N/A	N/A	Flare Traversable RT?	N/A	
8	and your			N/A	Landing Length (in)	N/A	N/A	DWS Provided?	N/A	
A A A A A A A A A A A A A A A A A A A	11	Surveyor Notes:		N/A	Landing Width (in)	N/A	N/A	DWS Contrast?	N/A	
L & L	Ed trad	N/A		N/A	Landing Slope (%)	N/A	N/A	DWS Length (in)	N/A

H. The second states	7.8.1	PROW/ADA:		N/A	Gutter Ponding?	N/A	N/A	Gutter Slope (%)	N/A	
	A A	Not Found, R304.5.3		N/A	Gutter Lip Ht (in)	2.0	N/A	Gutter X Slope (%)	N/A	
				N/A	Painted X Walk1?	No	N/A	Painted X Walk2?	N/A	
					X Walk 1 Direction	To NW		X Walk 2 Direction	N/A

es Surface Condition? (G/P)

Good
