Access Compliance Report Public Rights-of-Way (Curb Ramps)

Intersection ID: 48615 Main Street: HARRIS_STATION_BV Cross Street: ROCKY_RIVER_RD Location: S

ADA ID: 098BBA329ED9 Ramp Type: Perp Initial Pass/Fail: Fail Overall Compliance: No Severity Score: 21.25

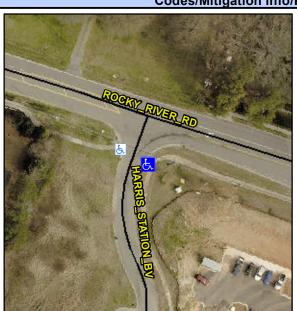
Not Found, R304.5.1, R304.2.2

Compliance Description <u>Data</u> Compliance Description Data No N/A Ramp Length (in) 74.0 Ramp Slope (%) 11.3 Ramp XSlope (%) No Ramp Width (in) 46.5 Yes 1.4 N/A N/A Flare Type LT N/A Flare Type RT N/A N/A N/A Flare Slope RT (%) Flare Slope LT (%) N/A N/A N/A Flare Traversable LT? N/A N/A Flare Traversable RT? N/A N/A N/A N/A DWS Provided? N/A Landing Length (in) N/A Landing Width (in) N/A N/A **DWS Contrast?** N/A N/A N/A Landing Slope (%) N/A DWS Length (in) N/A N/A Landing X Slope (%) N/A N/A DWS Full Width? N/A N/A Landing Curb? (Y/N) N/A N/A DWS Offset (in) N/A N/A N/A Shared Landing? N/A **Gutter Ponding?** N/A N/A Gutter Slope (%) N/A N/A Gutter Lip Ht (in) 1.0 N/A Gutter X Slope (%) N/A N/A Painted X Walk1? No N/A Painted X Walk2? N/A X Walk 1 Direction To NW X Walk 2 Direction N/A N/A N/A X Walk 1 Width (in) X Walk 2 Width (in) N/A X Walk 1 Slope (%) 2.7 X Walk 2 Slope (%) N/A X Walk 1 X Slope (%) 0.3 X Walk 2 X Slope (%) N/A N/A N/A N/A Ramp inside XWalk2? Ramp inside XWalk1? N/A Road Slope (%) N/A N/A Clear Space? N/A Road X Slope (%) N/A N/A Clear Space to XWalk (in) N/A N/A N/A Any Obstructions? N/A Storm Grate/Utility Hazard? N/A **Obstruction Type** Storm Grate/Utility Type N/A N/A Yes Surface Condition? (G/P) Good

Remove & Replace Entire Ramp.
