Access Compliance Report

Public Rights-of-Way

(Curb Ramps)

Intersection ID: N/A	Main Street: CENTER PARK DR	Cross Street: BEAM RD	Location: SE
ADA ID: 09B1FB62BF4E	Ramp Type: PerpDiag	Initial Pass/Fail: Fail	Overall Compliance: No
		Severity Score: 30

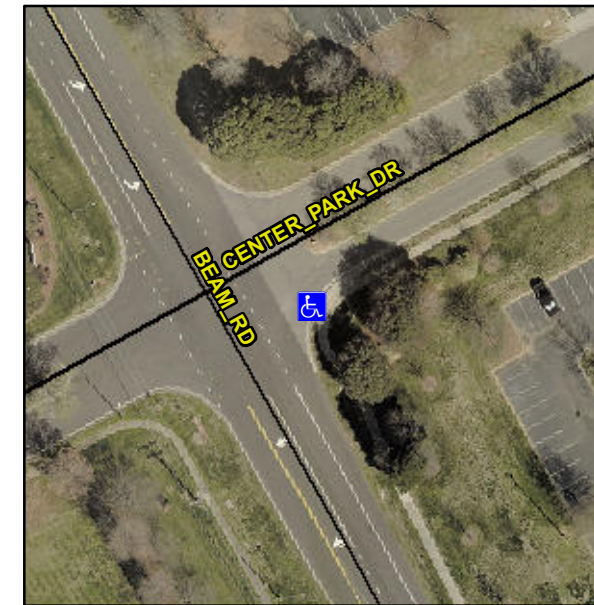
Not Found, R304.5.1, R304.5.3

Compliance	Description	Data	Compliance	Description	Data
N/A	Ramp Length (in)	108.0	Yes	Ramp Slope (%)	5.6
No	Ramp Width (in)	35.0	No	Ramp XSlope (%)	6.1
N/A	Flare Type LT	N/A	N/A	Flare Type RT	N/A
N/A	Flare Slope LT (%)	N/A	N/A	Flare Slope RT (%)	N/A
N/A	Flare Traversable LT?	N/A	N/A	Flare Traversable RT?	N/A
N/A	Landing Length (in)	N/A	N/A	DWS Provided?	N/A
N/A	Landing Width (in)	N/A	N/A	DWS Contrast?	N/A
N/A	Landing Slope (%)	N/A	N/A	DWS Length (in)	N/A
N/A	Landing X Slope (%)	N/A	N/A	DWS Full Width?	N/A
N/A	Landing Curb? (Y/N)	N/A	N/A	DWS Offset (in)	N/A
N/A	Shared Landing?	N/A			
N/A	Gutter Ponding?	N/A	N/A	Gutter Slope (%)	N/A
N/A	Gutter Lip Ht (in)	N/A	N/A	Gutter X Slope (%)	N/A
N/A	Painted X Walk1?	No	N/A	Painted X Walk2?	No
	X Walk 1 Direction	To N		X Walk 2 Direction	To W
N/A	X Walk 1 Width (in)	N/A	N/A	X Walk 2 Width (in)	N/A
	X Walk 1 Slope (%)	1.4		X Walk 2 Slope (%)	5.3
	X Walk 1 X Slope (%)	6.4		X Walk 2 X Slope (%)	1.9

N/A	Ramp inside XWalk1?	N/A	N/A	Ramp inside XWalk2?	N/A
	Road Slope (%)	6.6	N/A	Clear Space?	N/A
	Road X Slope (%)	6.1	N/A	Clear Space to XWalk (in)	N/A
N/A	Any Obstructions?	N/A	N/A	Storm Grate/Utility Hazard?	N/A
	Obstruction Type			Storm Grate/Utility Type	
		N/A			N/A
			Yes	Surface Condition? (G/P)	Good

Remove & Replace Curb Ramp With Two New Directional Ramps or Equivalent.
