Access Compliance Report

Public Rights-of-Way

(Curb Ramps)

Intersection ID: 21517	Main Street: BELLECHASSE_ST	Cross Street: COTILLION_AV	Location: SE
ADA ID: 09B3CF86E044	Ramp Type: PerpDiag	Initial Pass/Fail: Fail	Overall Compliance: No
		Severity Score: 22.5

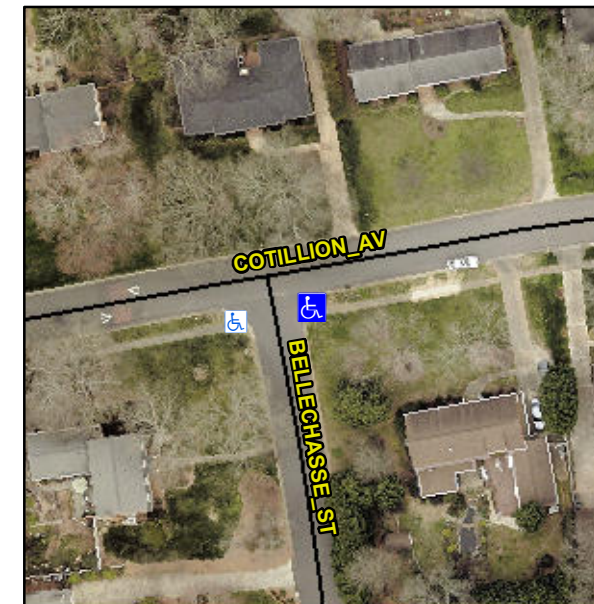
Not Found, R304.5.1, R304.2.2, R304.5.3

Compliance	Description	Data	Compliance	Description	Data
N/A	Ramp Length (in)	87.0	No	Ramp Slope (%)	11.3
No	Ramp Width (in)	43.0	No	Ramp XSlope (%)	3.3
N/A	Flare Type LT	N/A	N/A	Flare Type RT	N/A
N/A	Flare Slope LT (%)	N/A	N/A	Flare Slope RT (%)	N/A
N/A	Flare Traversable LT?	N/A	N/A	Flare Traversable RT?	N/A
N/A	Landing Length (in)	N/A	N/A	DWS Provided?	N/A
N/A	Landing Width (in)	N/A	N/A	DWS Contrast?	N/A
N/A	Landing Slope (%)	N/A	N/A	DWS Length (in)	N/A
N/A	Landing X Slope (%)	N/A	N/A	DWS Full Width?	N/A
N/A	Landing Curb? (Y/N)	N/A	N/A	DWS Offset (in)	N/A
N/A	Shared Landing?	N/A			
N/A	Gutter Ponding?	N/A	N/A	Gutter Slope (%)	N/A
N/A	Gutter Lip Ht (in)	N/A	N/A	Gutter X Slope (%)	N/A
N/A	Painted X Walk1?	No	N/A	Painted X Walk2?	No
	X Walk 1 Direction	To N		X Walk 2 Direction	To W
N/A	X Walk 1 Width (in)	N/A	N/A	X Walk 2 Width (in)	N/A
	X Walk 1 Slope (%)	6.0		X Walk 2 Slope (%)	0.2
	X Walk 1 X Slope (%)	1.6		X Walk 2 X Slope (%)	0.5

N/A	Ramp inside XWalk1?	N/A	N/A	Ramp inside XWalk2?	N/A
	Road Slope (%)	2.0	N/A	Clear Space?	N/A
	Road X Slope (%)	2.1	N/A	Clear Space to XWalk (in)	N/A
N/A	Any Obstructions?	N/A	N/A	Storm Grate/Utility Hazard?	N/A
	Obstruction Type			Storm Grate/Utility Type	
		N/A			N/A
			Yes	Surface Condition? (G/P)	Good

Remove & Replace Curb Ramp With Two New Directional Ramps or Equivalent.
